Sanitary Survey Review for Carlingford Lough

With Shoreline and Bacteriological Surveys

Produced by AQUAFACT part of the APEM group

On behalf of The Food Standards Agency in Northern Ireland

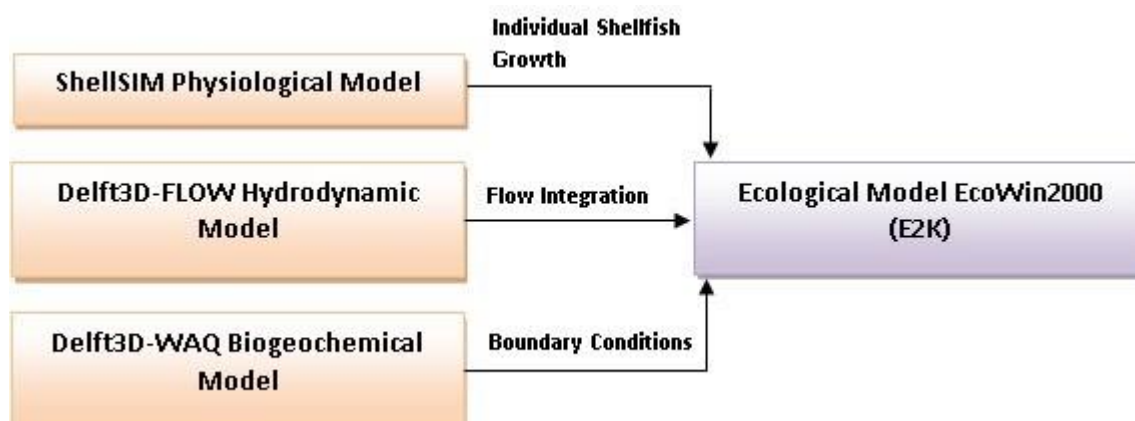
Figure 3.4: General modelling framework used in SMILE (Ferreira *et al.*, 2007).

The Delft3D-FLOW hydrodynamic model was used to simulate the tidal, wind and ocean currents within the lough (Ferreira *et al.*, 2008). This model was combined with the Delft3D-WAQ model to stimulate circulation and phytoplankton productivity for periods of up to 1 year and used to generate aggregated water exchange and boundary conditions for the lough. ShellSIM is a generic dynamic model structure which simulates feeding, metabolism and growth. EcoWin2000 (E2K) is an ecological model that provides a platform for integration of the various other models. It typically divides coastal systems into (<100) boxes, which can be structured in one, two or three dimensions and performs simulations at the system scale, using water exchange across box faces and system boundaries which are up-scaled from detailed hydrodynamic models.

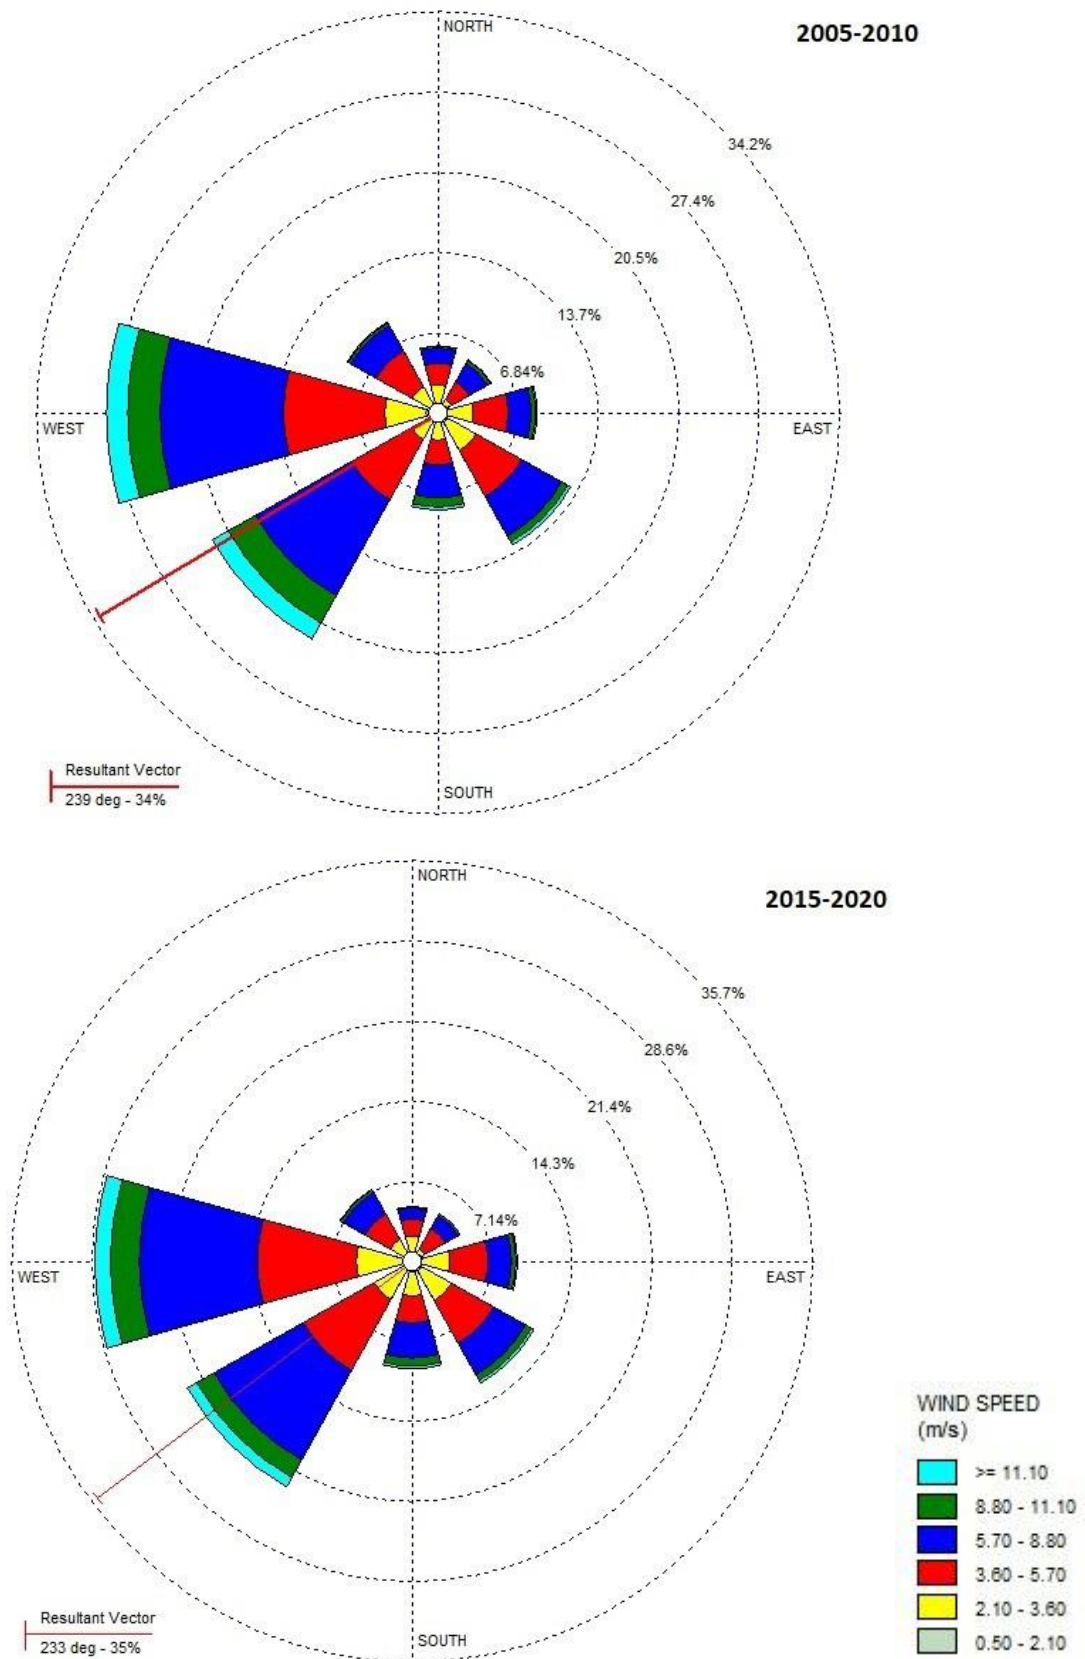
Figure 3.12: Wind roses for Dublin Airport from 2005 to 2010 and 2015 to 2020. (Source: Met Eireann, 2021).

Wind conditions affect the hydrodynamic conditions in Carlingford Lough by generating wind-induced currents and waves. Of these phenomena, wind-induced waves are an important factor in the process of sediment resuspension and transport. Wind waves are produced by the local prevailing wind. They travel in the direction of the prevailing wind, i.e. a southwesterly wind will produce northeasterly moving waves. The height of wind waves depends on:

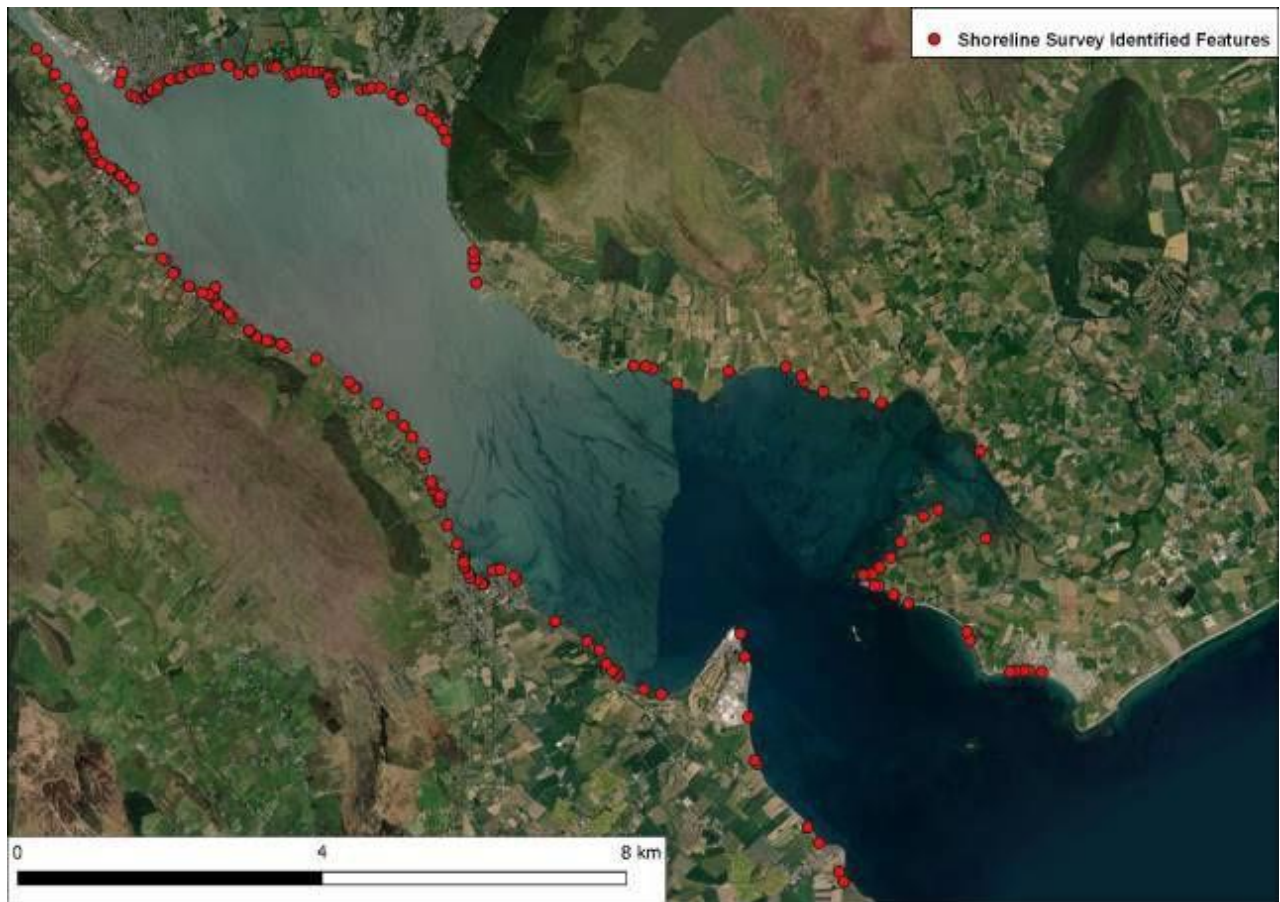
Figure 4.49: Location of features identified during shoreline survey.

Features identified during the shoreline survey include 151 discharges, 37 rivers/streams, 15 piers, 30 slipways, 8 locations with livestock and 2 locations with birds feeding on the shore. The 2010 shoreline survey recorded 69 discharges. A greenway was constructed along the southern side of the lough in 2018. Surface water discharges installed as part of this development account for a large proportion of the extra discharges. A number of extra discharge points were also recorded between Warrenpoint and Rostrevor, which were mostly for road runoff or land drainage from private properties. Overall, very few of the discharges and watercourses recorded during this survey showed any signs of nutrient enrichment or contamination.

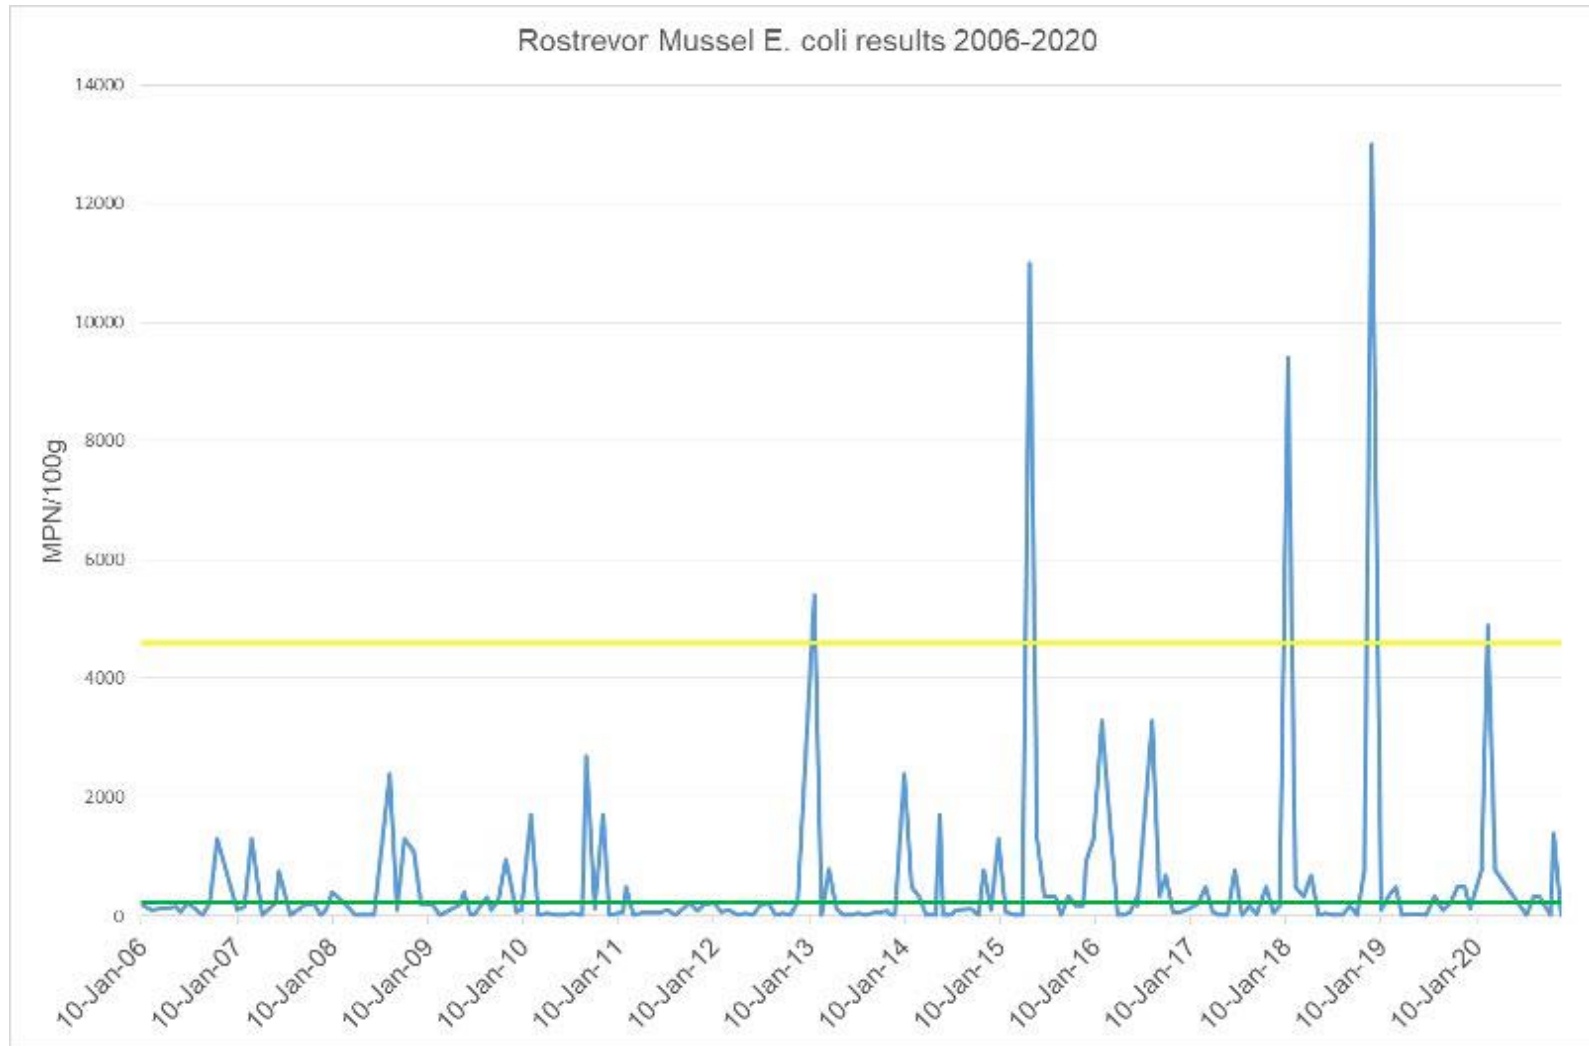
Figure 5.74: *E. coli* levels from mussels at C1 Rostrevor from 2006 - 2020 (Source: FSA in NI).

C1 Rostrevor mussels had a **B** classification for all year except 2007 and 2008 when they received an **A** classification.
