**Sanitary Survey Report and Sampling Plan
for Oysterhaven, Co. Cork**

AQUAFACT - APEM Group

The Sea Fisheries Protection Authority

December 2024

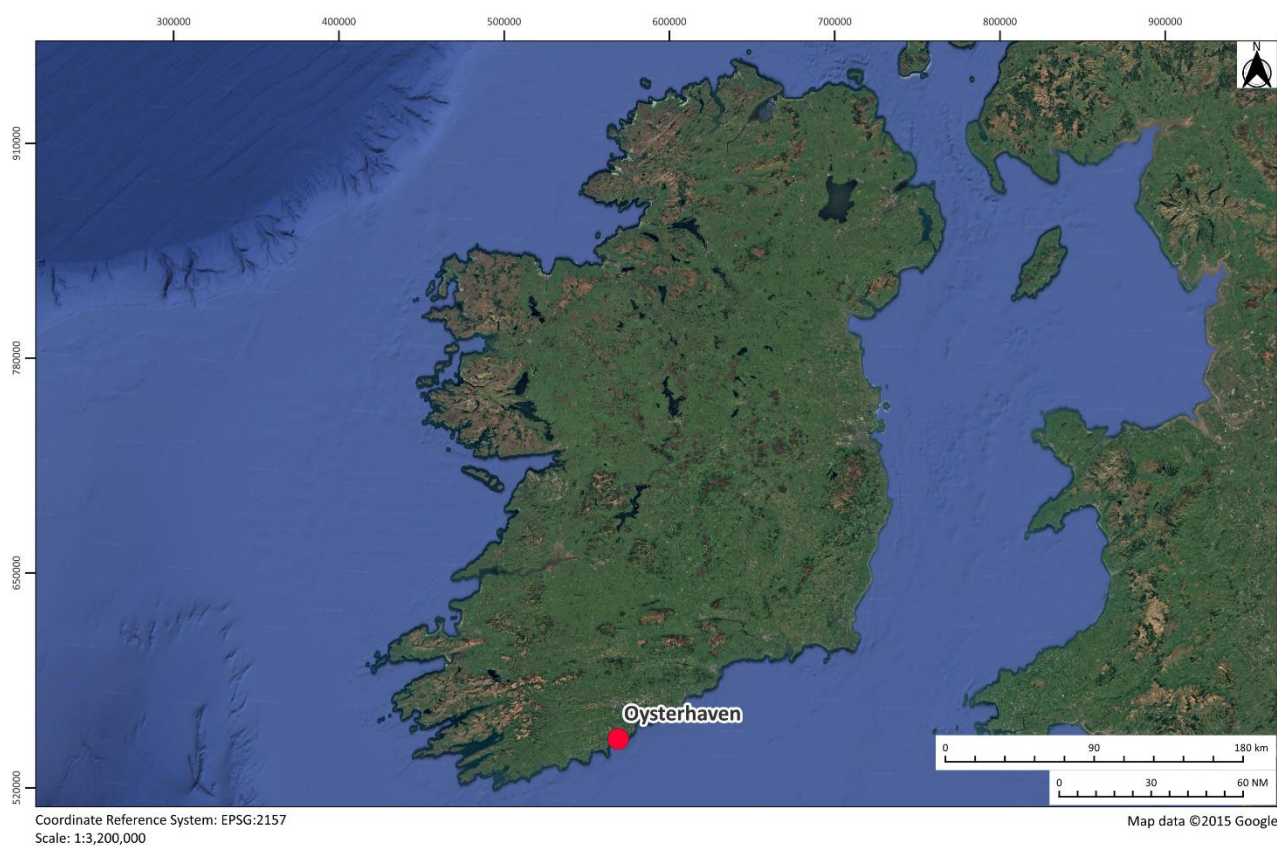
Figure 3-1: Location of Oysterhaven Bay, Co. Cork.

Oysterhaven is a large Y-shaped sea inlet situated on the southern coast of Co. Cork (**Figure 3-1**), between Kinsale and the entrance to Cork Harbour. The exposed rocks around Oysterhaven were deposited during the late Devonian and Carboniferous periods (370 – 310 million years ago) and have been weakly metamorphosed (Pracht, 1994). The designated shellfish area within the bay is 1.5 km², encompassing the shoreline southwest of Mountlong to the shoreline east of Garraha to a point southwest of Rathmore and up the inlet to Ballinaclashet (**Figure 3-2**).

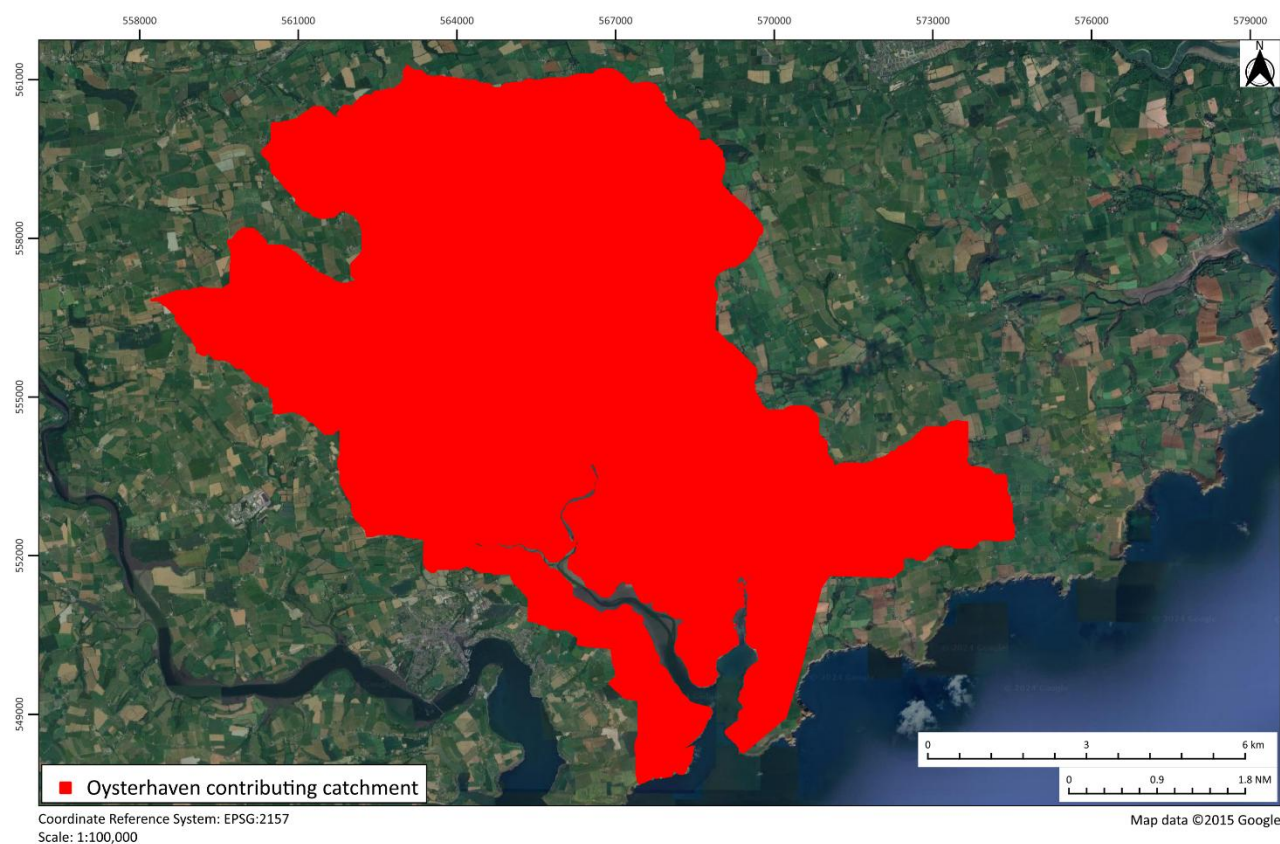
Figure 7-1: Oysterhaven contributing catchment established for the assessment of pollution sources into the Oysterhaven bivalve mollusc production area.

Pollution sources were considered within the contributing catchment of Oysterhaven (**Figure 7-1**). The contributing catchment covers an area of approximately 98.5 km².

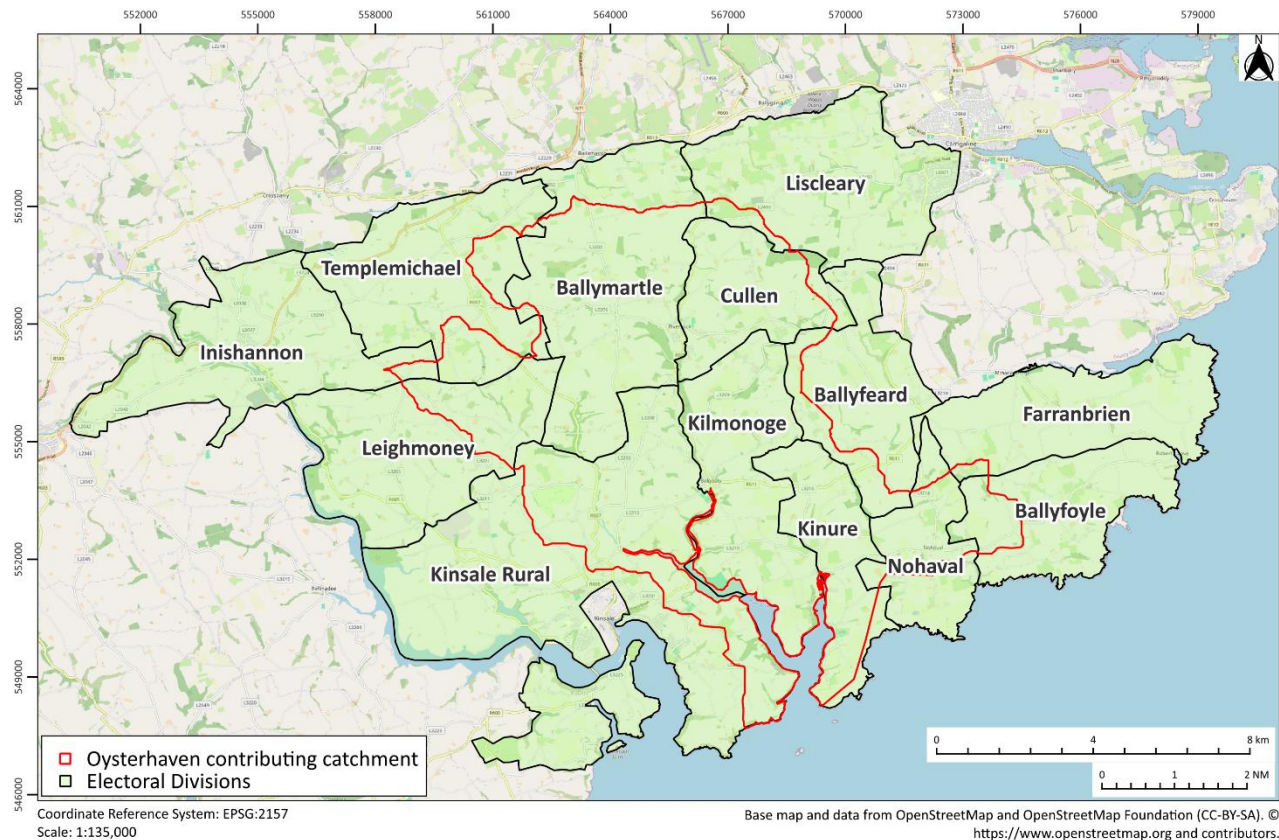
Oysterhaven contributing catchment overlaps 13 EDs; 12 of these EDs overlap partially and Kilmonoge ED overlaps entirely with the contributing catchment. The EDs partially within the contributing catchment are Ballyfeard, Ballyfoyle, Ballymartle, Farranbrien, Inishannon, Kinsale Rural, Kinure, Leighmoney, Liscleary, Nohaval, Templemichael, and Cullen.

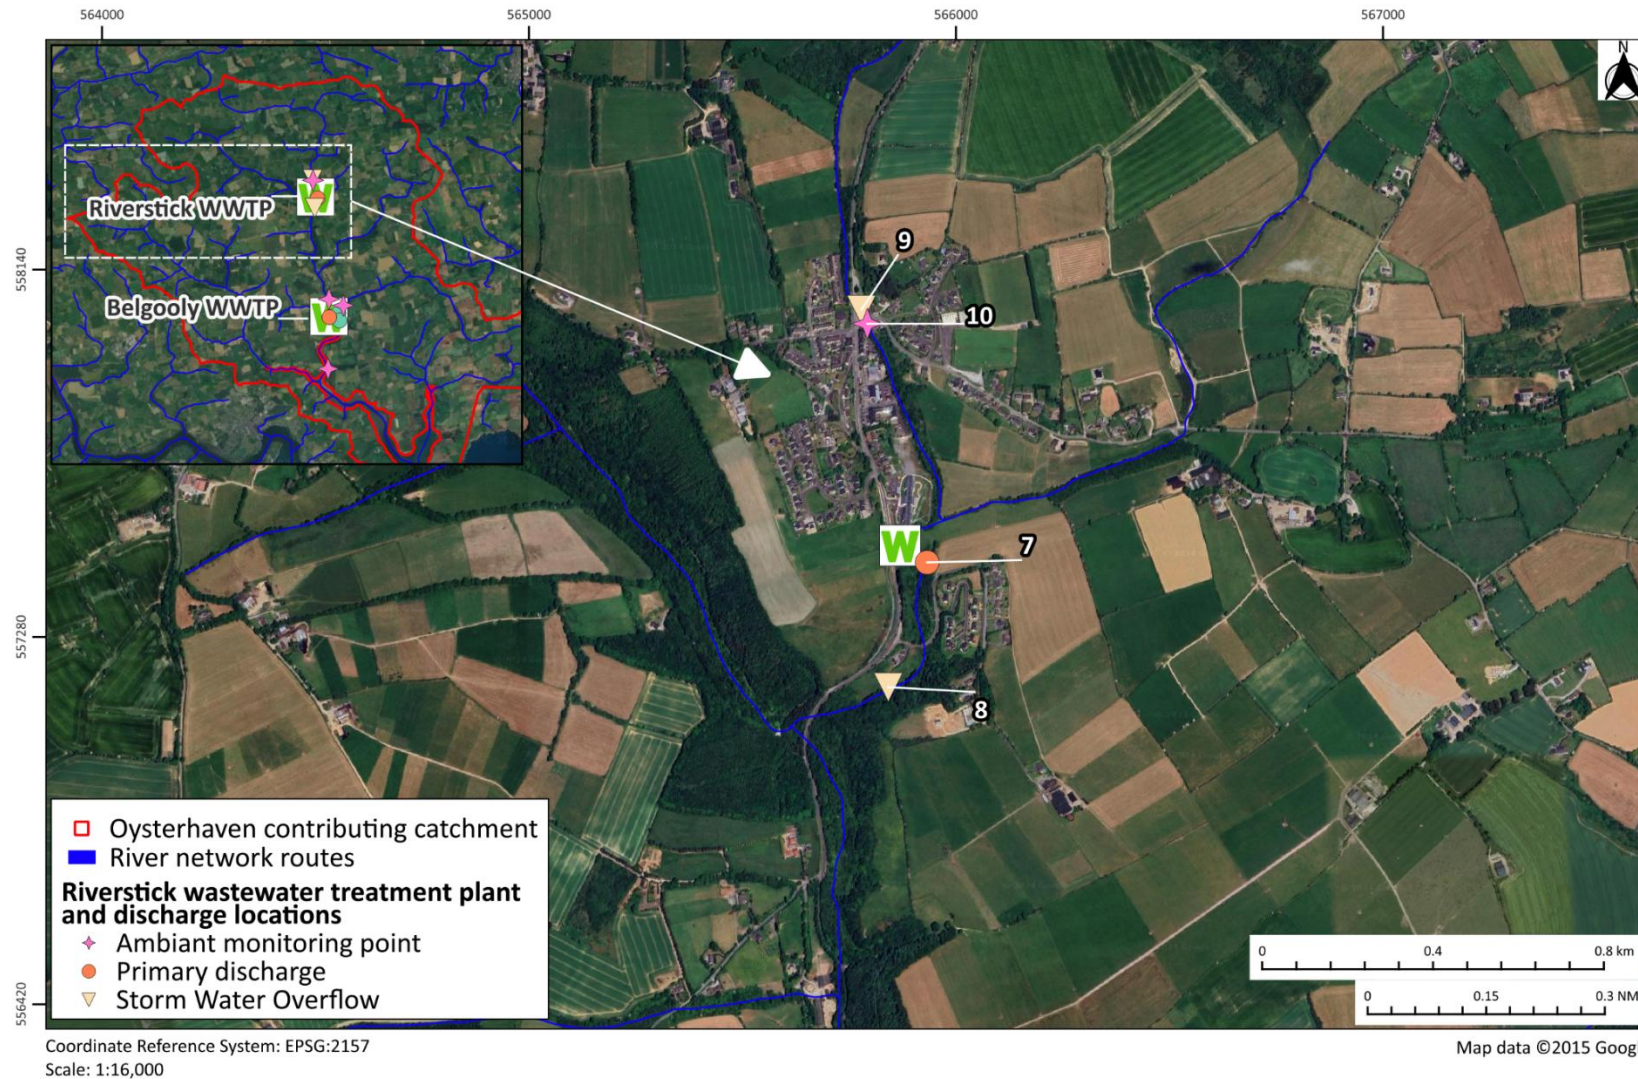
The Riverstick WWTP (D0433-01) (**Figure 7-6**) has a design capacity of 1,000 but currently operates under capacity at a PE of 657¹⁵. Like Belgooly, Riverstick WWTP is a tertiary treatment facility. This WWTP is designed to have a peak hydraulic capacity of 675 m³/day and in 2023 was operating at an average hydraulic loading to the WWTP of 184.83 m³/day¹⁵. Riverstick WWTP has a DWF rate of 225 m³/day. The capacity of the Riverstick WWTP was not anticipated to be exceeded in the following three years after the 2023 AER for Riverstick was written¹⁵, and it was noted that no apparent negative impact was caused by discharges from the Riverstick on WFD status (**Figure 8-11**).

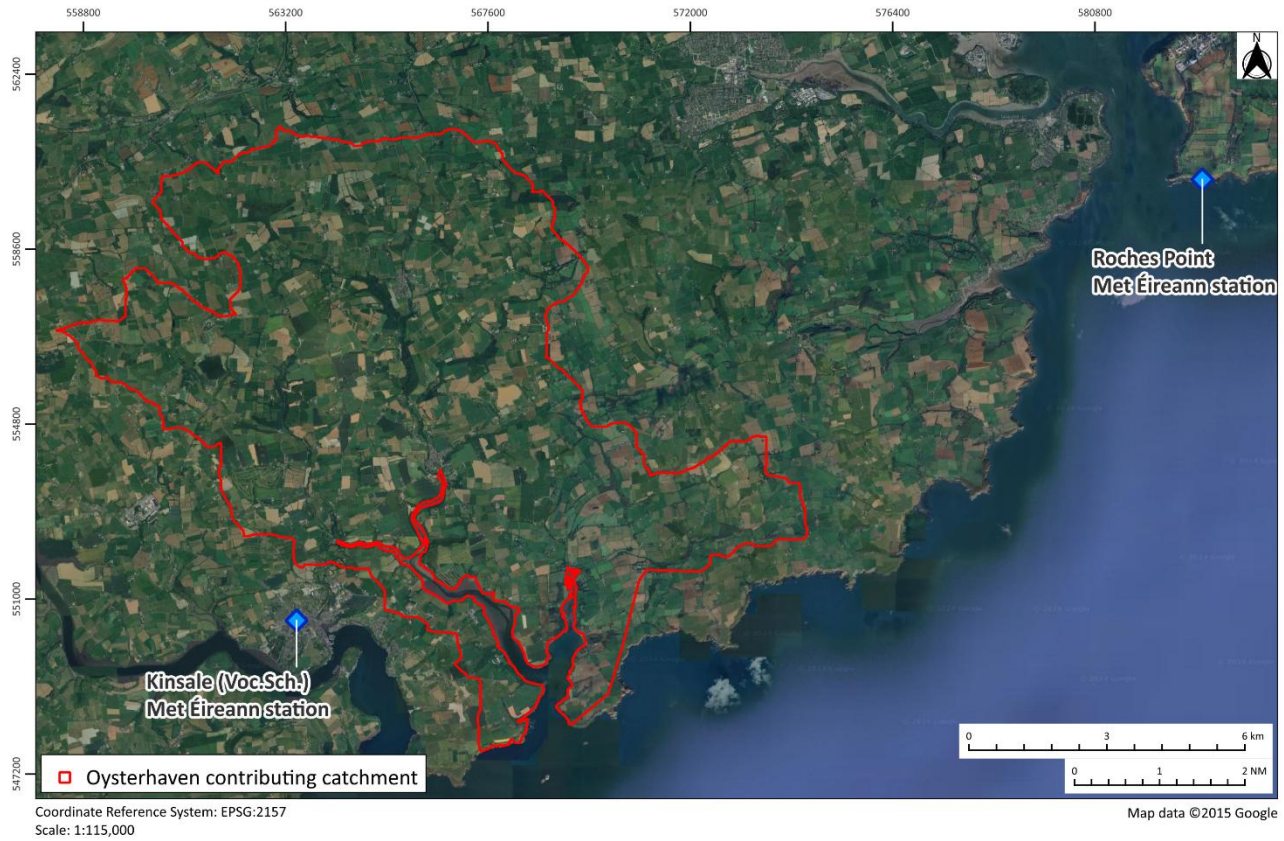
Figure 8-14: Location of Kinsale and Roches Point Met Éireann stations in relation to Oysterhaven contributing catchment.

Wind data from 2019-2023 from Roches Point Met Éireann⁵⁰ station (**Figure 8-14**) are displayed in **Table 8.1** and **Table 8.2** below, and wind roses for each corresponding year can be seen in **Figure 8-2** to **Figure 8-4**.
