Sanitary Survey Report and Sampling Plan for Inver Bay, Co. Donegal

Produced by

AQUAFACT - APEM Group

October 2023

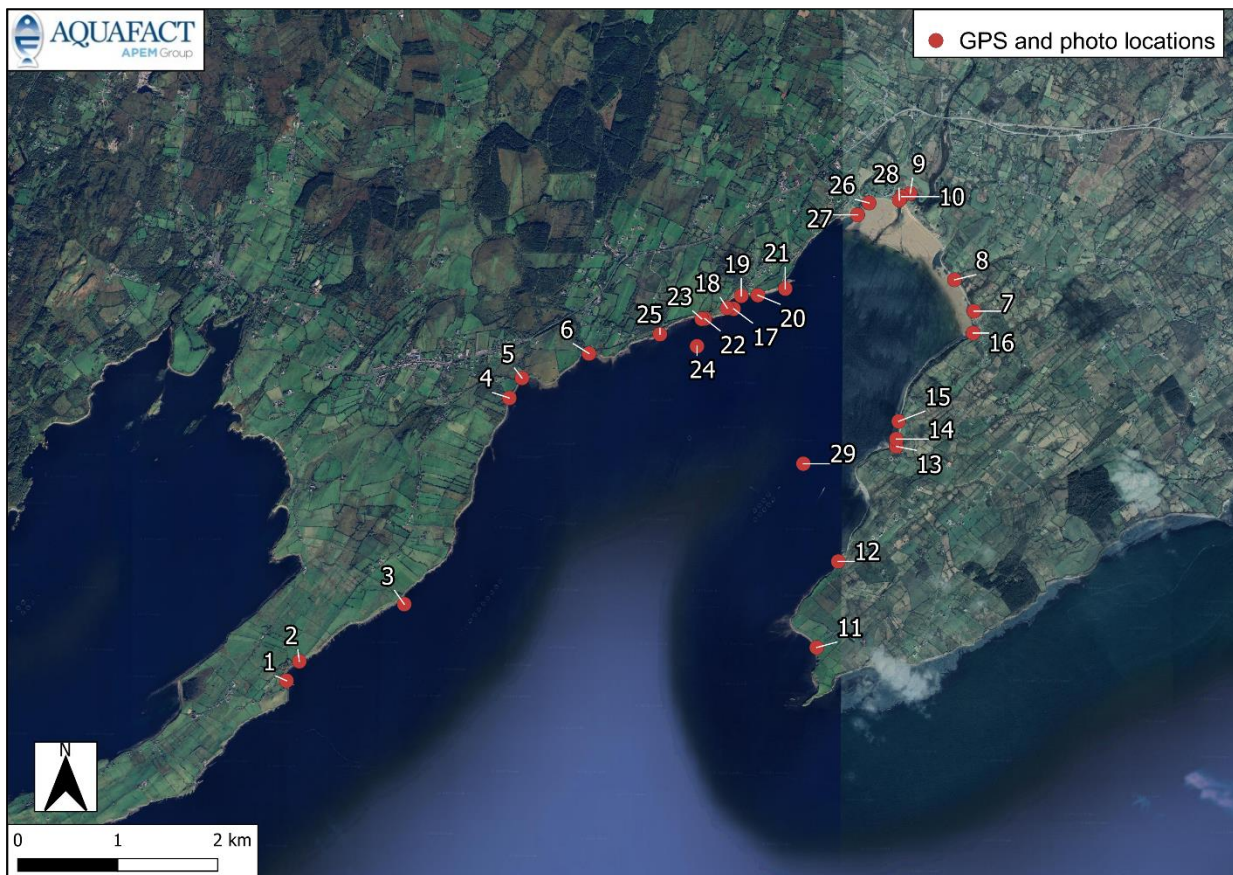
Figure 7-18: Locations of GPS and photograph sites from the shoreline survey (numbering cross-referenced to Table 7.11).

Figure 7-18 shows the locations of all features observed during the shoreline survey. In total 29 features were identified (see **Appendix 4:** Shoreline Survey Images), of which seven rivers/streams were identified, in excess of 14 drains/pipes, one culvert, four piers, one location with four sheep and three locations with fish

The shoreline survey revealed a number of human inputs via more than 14 drains/pipes (**Table 7.11**) and one culvert (**Figure 7-18**, map ID 19). The latter had a good flow of water at the time of the survey, with a lot of *Enteromorpha/Ulva* algae and moss observed. The water that passed through the culvert appeared to originate from mixed scrubland and a residential area.

Due to the numbers of animals quoted above, it is expected that sheep are one of the principal pollution sources in the production area particularly after periods of elevated rainfall when surface water runoff may bring more faecal contamination into the bay; it is of note that the ED of An Ghrafaidh is located the furthest away geographically from the Inver Bay DSW boundary. Four sheep were noted on the shore during the shoreline survey (**Figure 7-18**, map ID 2).

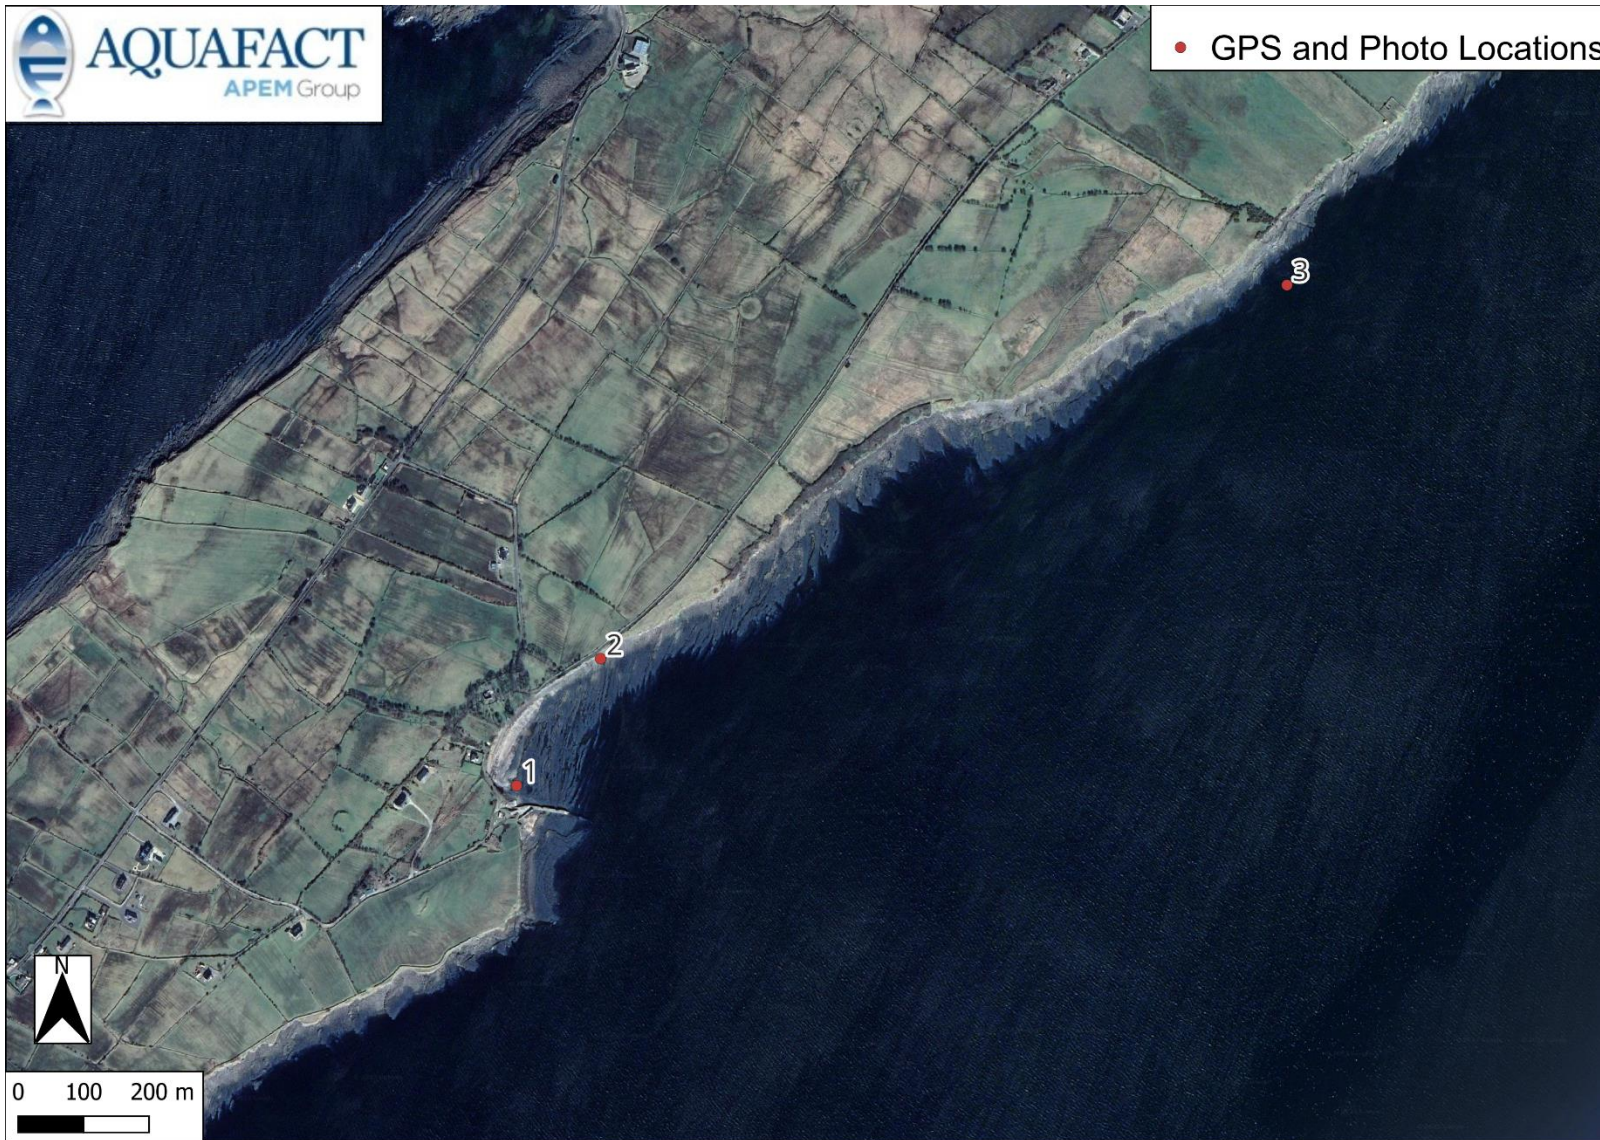
Figure 7-19: Features 1-3 identified during the shoreline survey (numbering cross-reference to Table 7.11).

16	Drain	Likely field drain. Low flow. Some algae noted at mouth on shore.	54.63488	-8.27245	582410.0	876330.6
17	Pier	Pier. Six/seven open style fishing boats.	54.63697	-8.30956	580015.1	876573.1
18	Pipes	Pipes x 2. No flow. Likely surface from road/pier above	54.63704	-8.31055	579951.3	876581.2
19	Culvert	Culvert, good flow of water. Lot of <i>Enteromorpha</i> algae and moss. Flowing through mixed scrub/residential area.	54.63814	-8.30838	580091.9	876703.0
20	Stream	Good flow of water. Clear. Flowing through mixed scrub/rough grazing.	54.63821	-8.30581	580257.8	876710.1
21	Pipes	Pipes x numerous. Surface water from hard surface above associated with pier and commercial buildings.	54.6388	-8.30158	580531.2	876774.6
22	Drain	Field drain, good flow. Flowing though area of rough pasture.	54.63608	-8.31402	579726.8	876475.4
23	Drain	Field drain, medium flow. Flowing though area of rough pasture.	54.63606	-8.3145	579695.8	876473.3

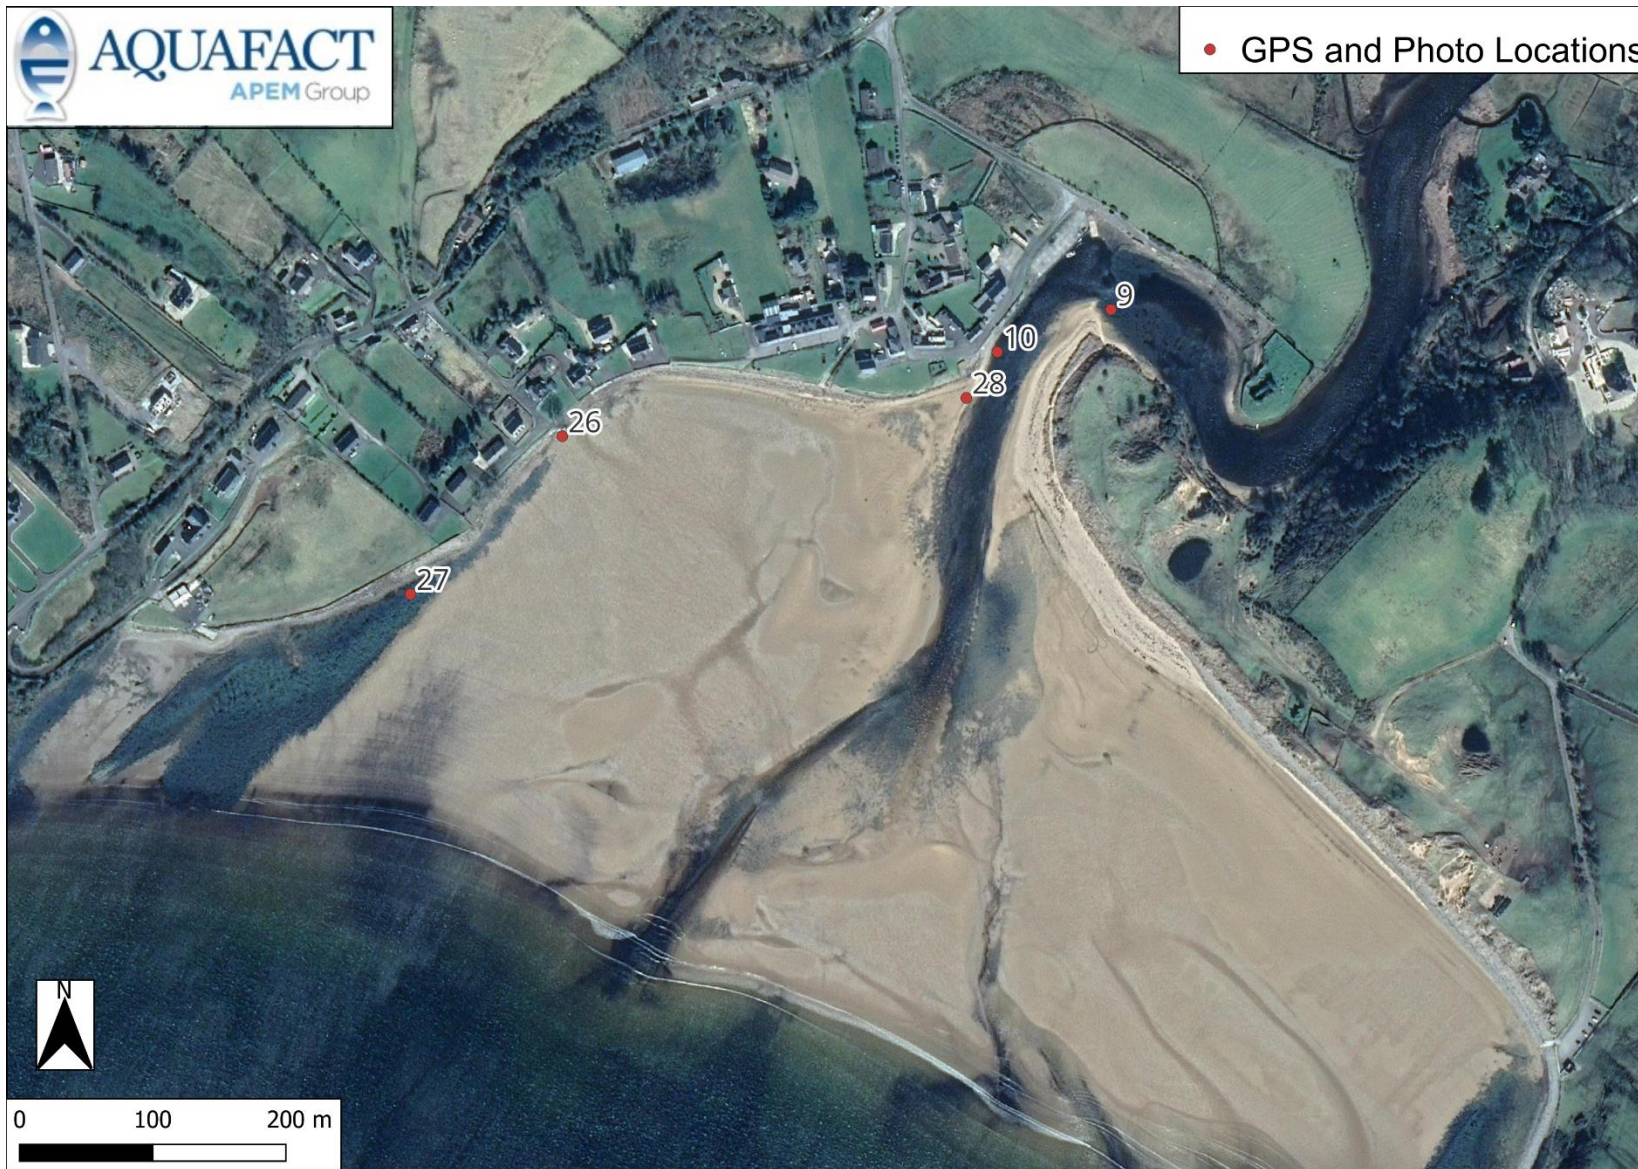
Figure 7-22: Features 9-10 and 26-28 identified during the shoreline survey (numbering cross-reference to Table 7.11).

24	Fish Farm	Salmon farm.	54.6336	-8.31521	579648.7	876199.7
25	Drain	Field drain coming off cliff/hill face. Steady flow. Coming through area of rough grazing.	54.63466	-8.32096	579278.0	876319.3
26	Pipes	Grated pipes. Steady flow. A lot of green moss and algae visible at mouth of water outlet. Flowing through residential and rough grazing.	54.64653	-8.28866	581368.8	877631.4
27	Pipes	Numerous. Not flowing. Surface water run off pipes from hard road surface behind.	54.64546	-8.29042	581254.7	877512.8
28	Pipe	Large bore grey pipe. No flow.	54.6468	-8.28396	581672.3	877660.2
29	Fish Farm	Salmon farm. Boat also.	54.62309	-8.29866	580712.3	875025.3

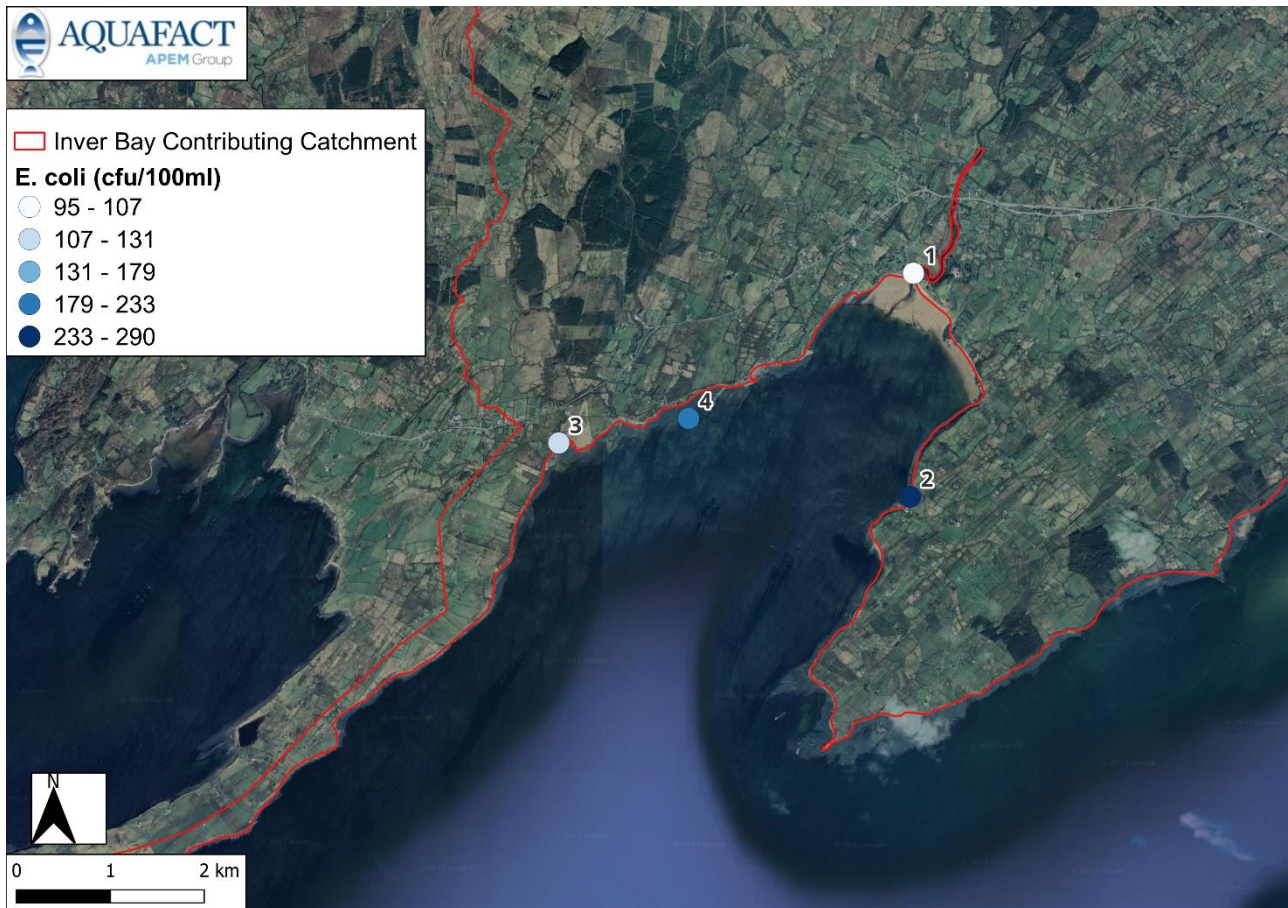
Figure 9-1: Location and magnitude of *E. coli* results from water samples taken during the shoreline survey (numbering cross-referenced to Table 9.5).

Station No.	<i>E. coli</i> (cfu/100 ml)	Latitude	Longitude
1	95	54.64703	8.283664
2	290	54.62566	8.284077
3	115	54.630647	8.342095
4	195	54.633054	8.32069

The highest recorded *E. coli* result from the shoreline survey water sampling was taken next to a stream, near a field drain discharging to the northeast of the mussel production area (**Figure 9-1**). However, considering the above mentioned computed tidal velocities and directions, this discharge is not likely to interact with the production area. Additionally, this stream is not located near a WWTP, and no sheep were noted in the area during the shoreline survey, and as this stream is small the discharge will be diluted into the bay relatively quickly reducing any potential impact on the production area.
