**Sanitary Survey Report  
and  
Sampling Plan  
for Roaringwater Bay**

**The Sea Fisheries Protection Authority**  
January 2023  
Amended July 2024

Client	Sea Fisheries Protection Authority
Report Title	Sanitary Survey & Sampling Plan for Roaringwater Bay
Job Number	JN1520
Report Status	Final – Amended
Issue Date	18/07/2024

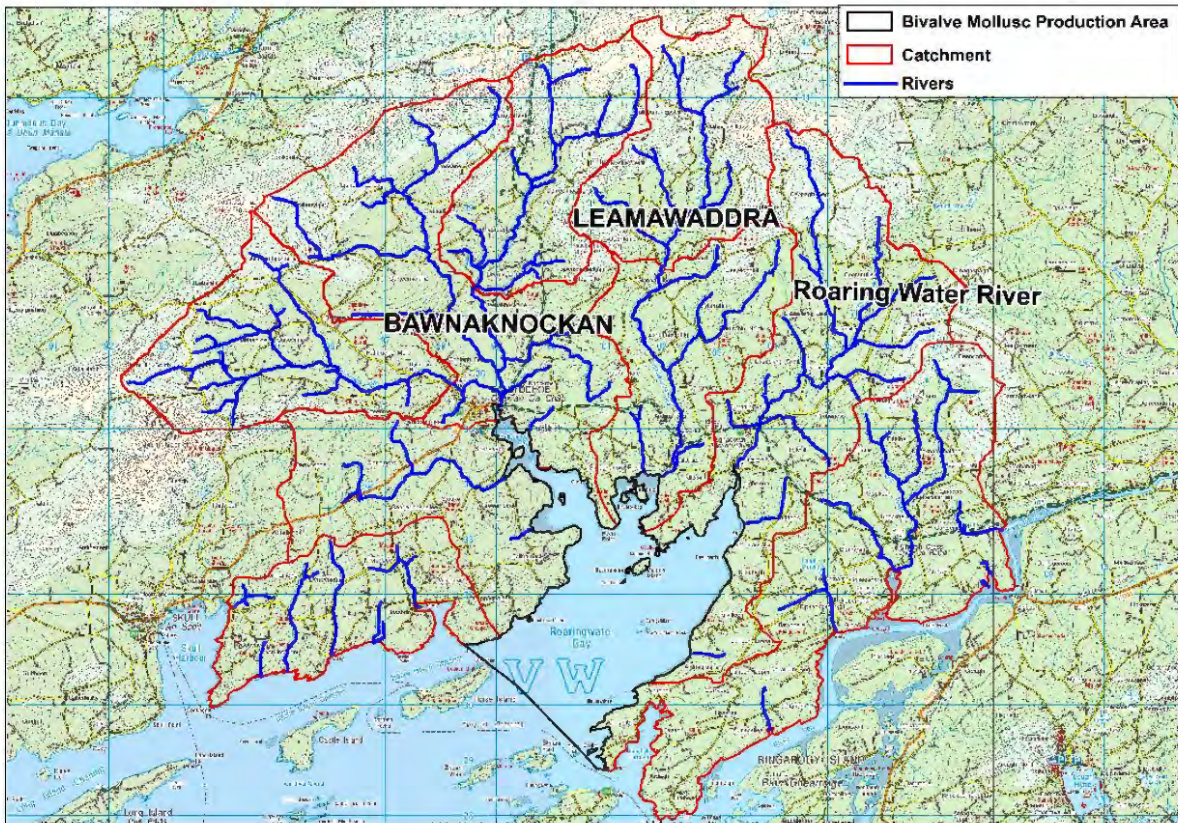
Figure 7-4: Rivers in the Roaringwater Bay catchment area (Source: EPA, 2019).

Roaringwater Bay drains a catchment of 126.8km<sup>2</sup>, the majority of the catchment is drained by three rivers the Bawnaknockane River (33.6%, 42.6km<sup>2</sup>), Leamawadra River (17.5%, 22.23km<sup>2</sup>) and Roaringwater River (15.7%, 19.93) (Figure 7-4). The remainder of the catchment is drained by a series of small unnamed streams.

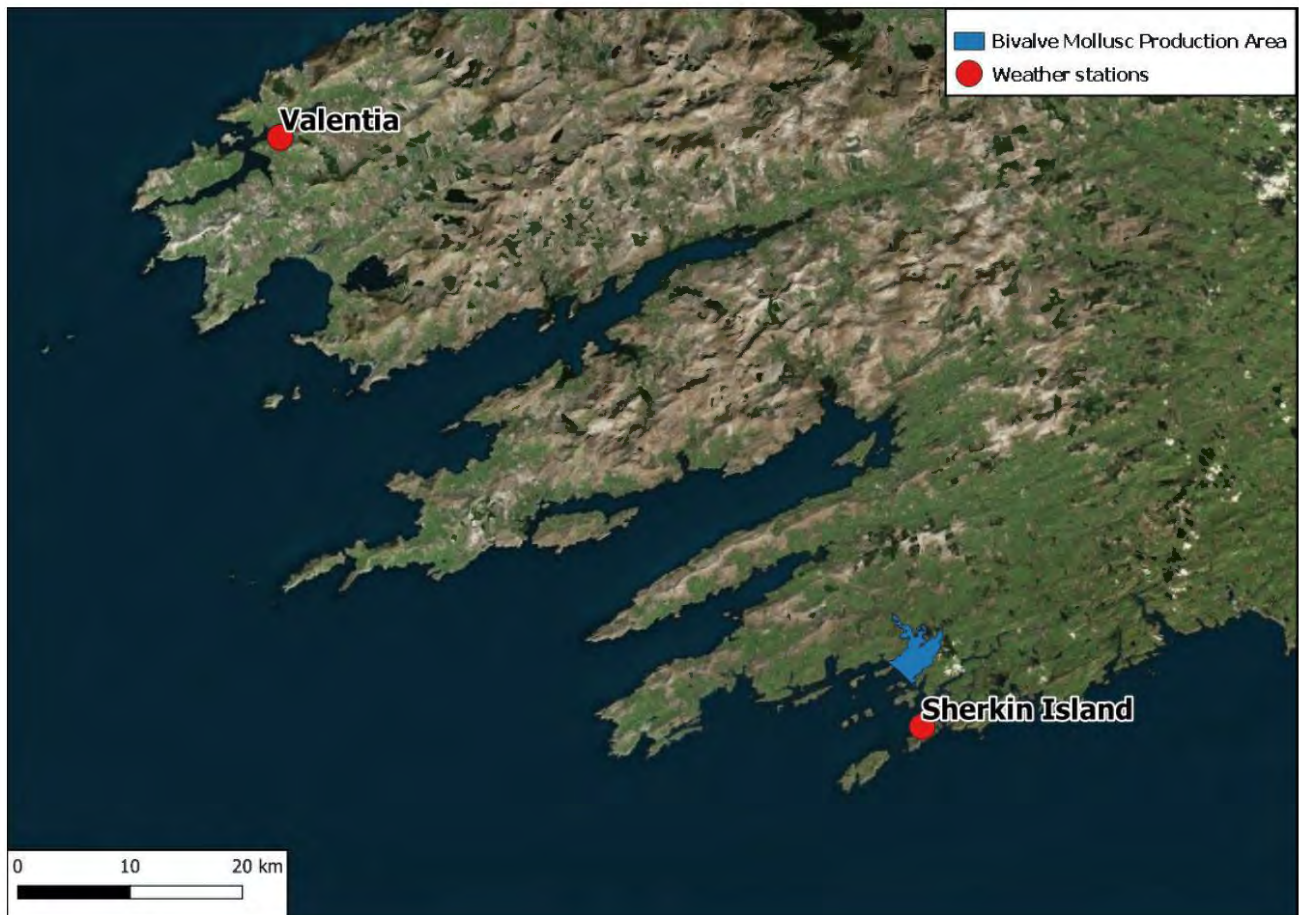
**Figure 7-7: Location of Met Eireann weather stations in relation to the Roaringwater Bay production area.**

Table 7.6 shows total monthly rainfall at the Sherkin Island Met Eireann station (see Figure 7-7), located c. 5 km south of the Roaringwater Bay production area from 2016 to 2020 (Met Eireann, 2020a).
