**Sanitary Survey Report
and
Sampling Plan
for Sruwaddacon Bay**

AQUAFACT International Services Ltd

**The Sea Fisheries Protection Authority
September 2021**

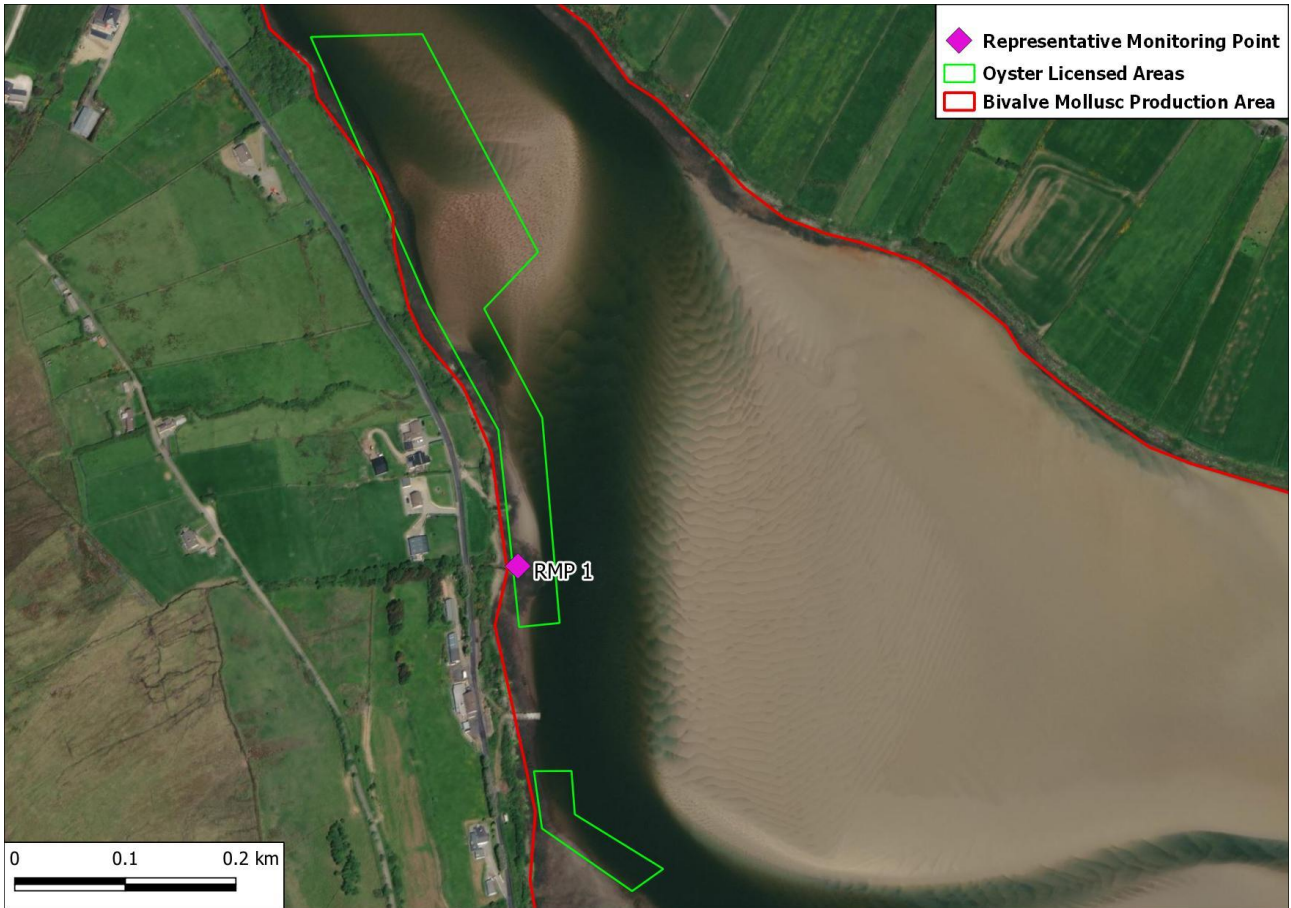
Figure 5.1: Bivalve Mollusc Classified Production Area with RMP for Sruwaddacon Bay.

It is recommended that the location of RMP 1 for Pacific oysters is situated on the south western shore of the bay in the larger of the two licensed areas. (Figure 5.1, Table 5.1).

It is recommended that 12 – 18 individuals of market size (minimum shell length 7.5 cms) should be collected for microbiological monitoring of the bivalve mollusc production area. As harvesting can take place throughout the year, sampling needs to be on a monthly basis all year round.

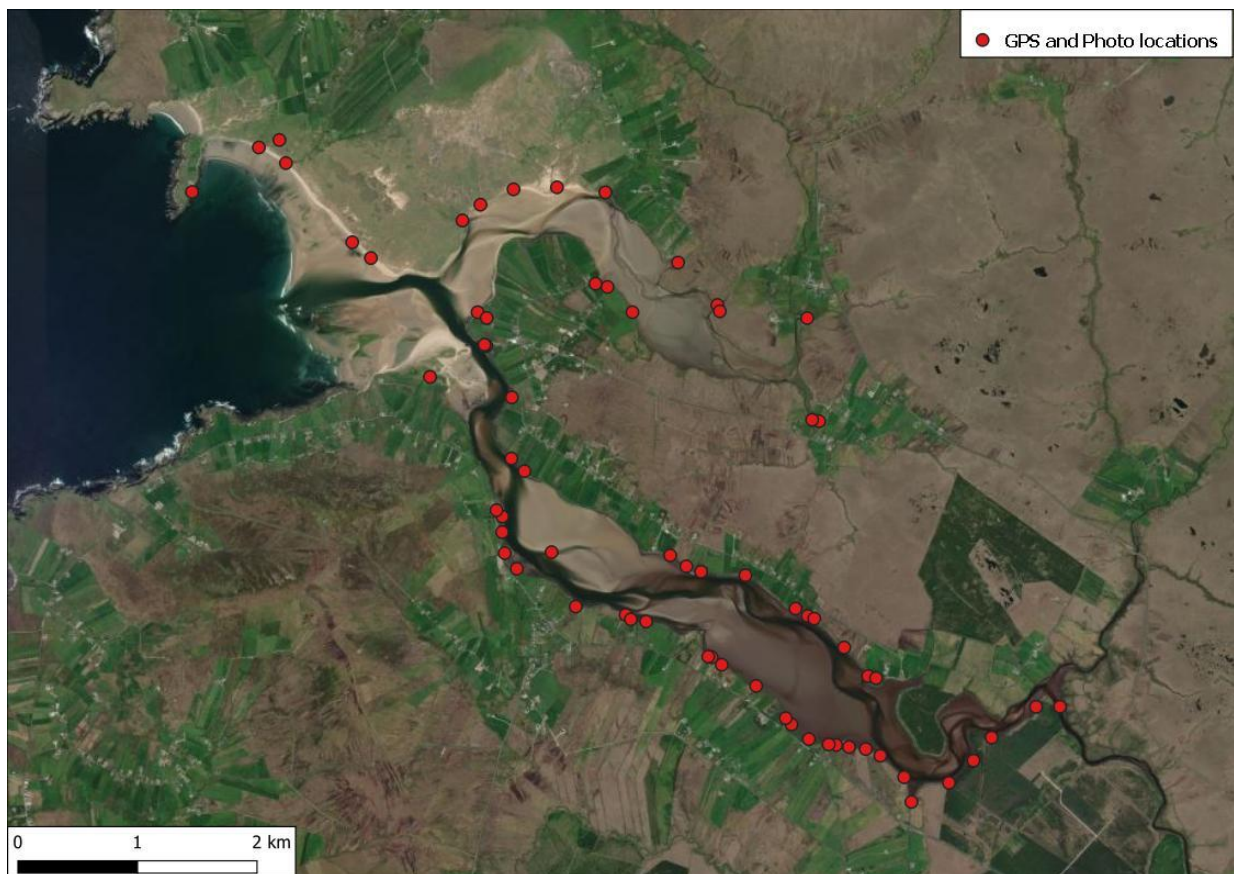
Figure 6.18: Locations of GPS and Photograph Sites.

Figure 6.18 shows the locations of all features observed during the shoreline survey. In total 68 features were identified, of which 15 rivers/streams were identified, 44 drains, 3 piers, 5 locations with sheep and 1 location with cattle. Figure 6.19 to Figure 6.34 show aerial imagery of the location of the features and

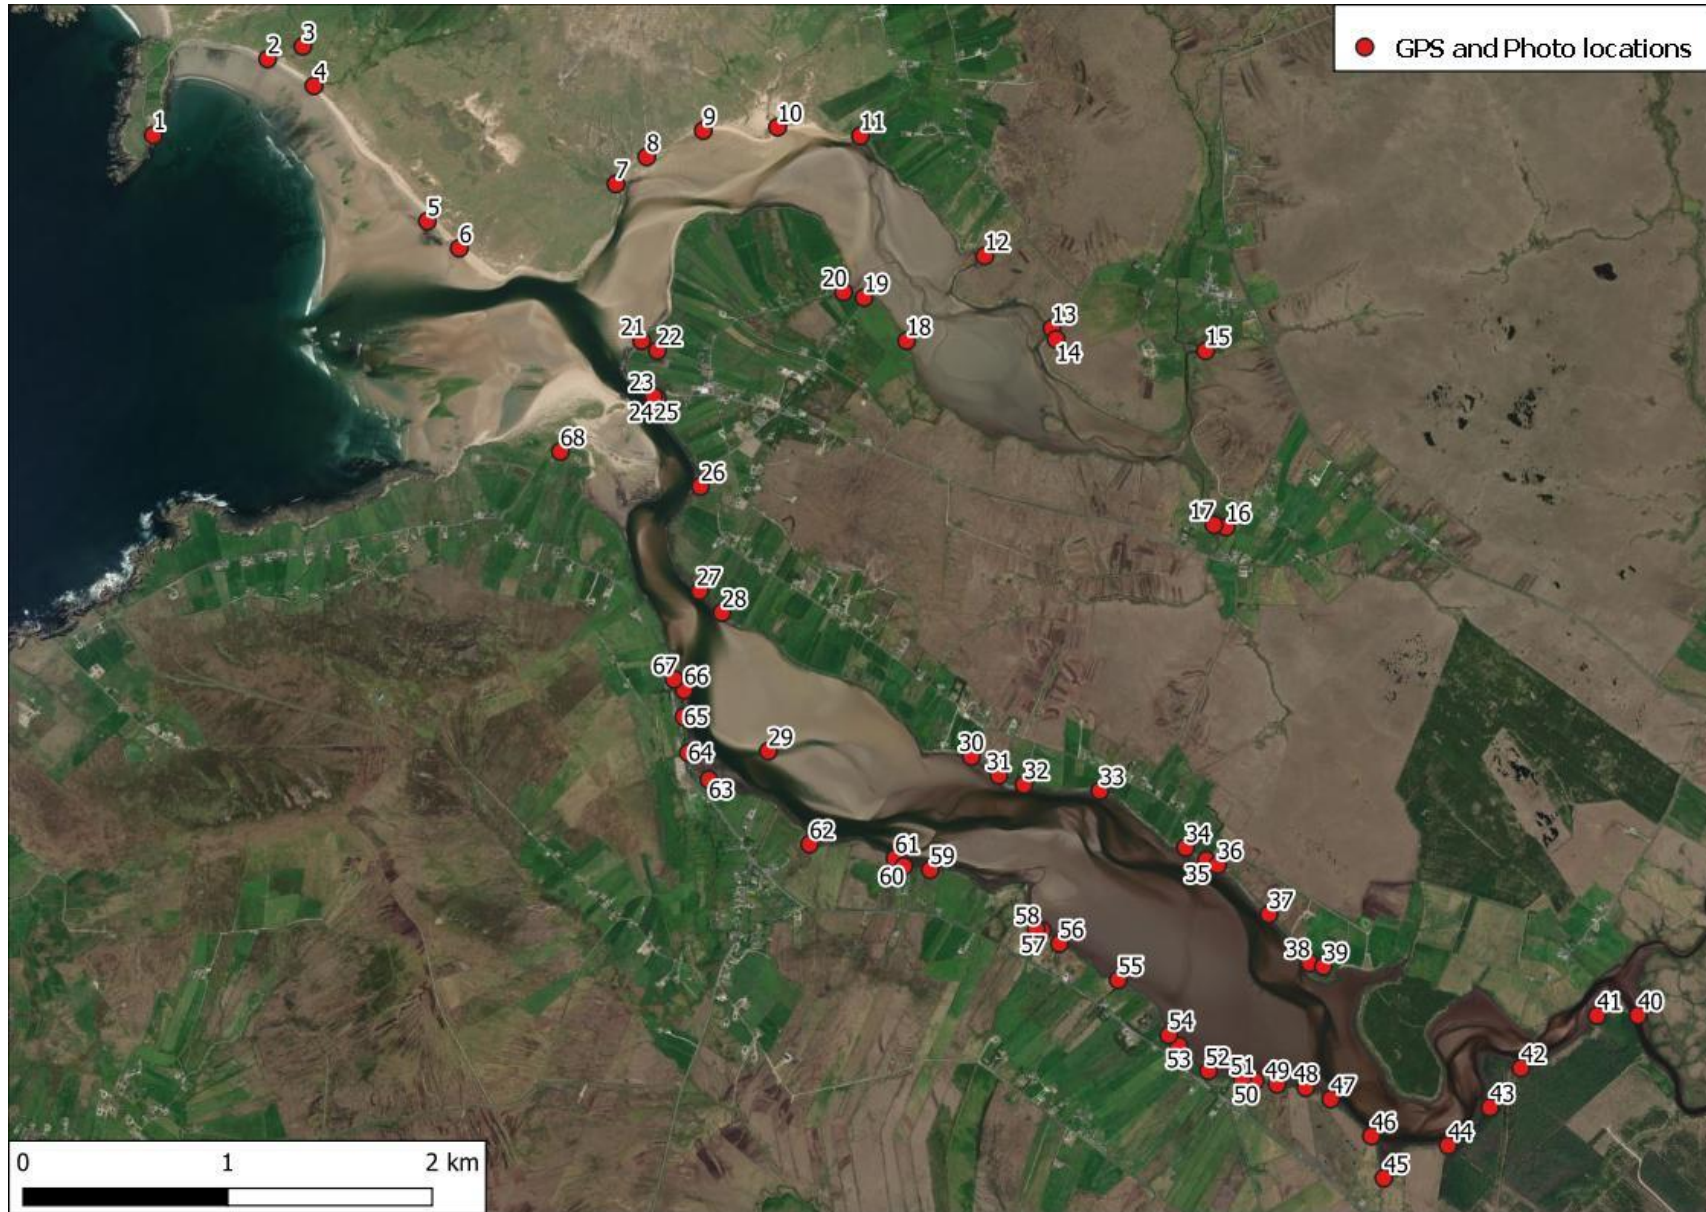
Figure 6.19: All features (numbering cross-reference to Table 6.8) identified during the shoreline survey.

Appendix 4 shows images of most of these features. Table 6.8 details all features identified and the numbering used is cross-referenced to Figure 6.19 to Figure 6.34.

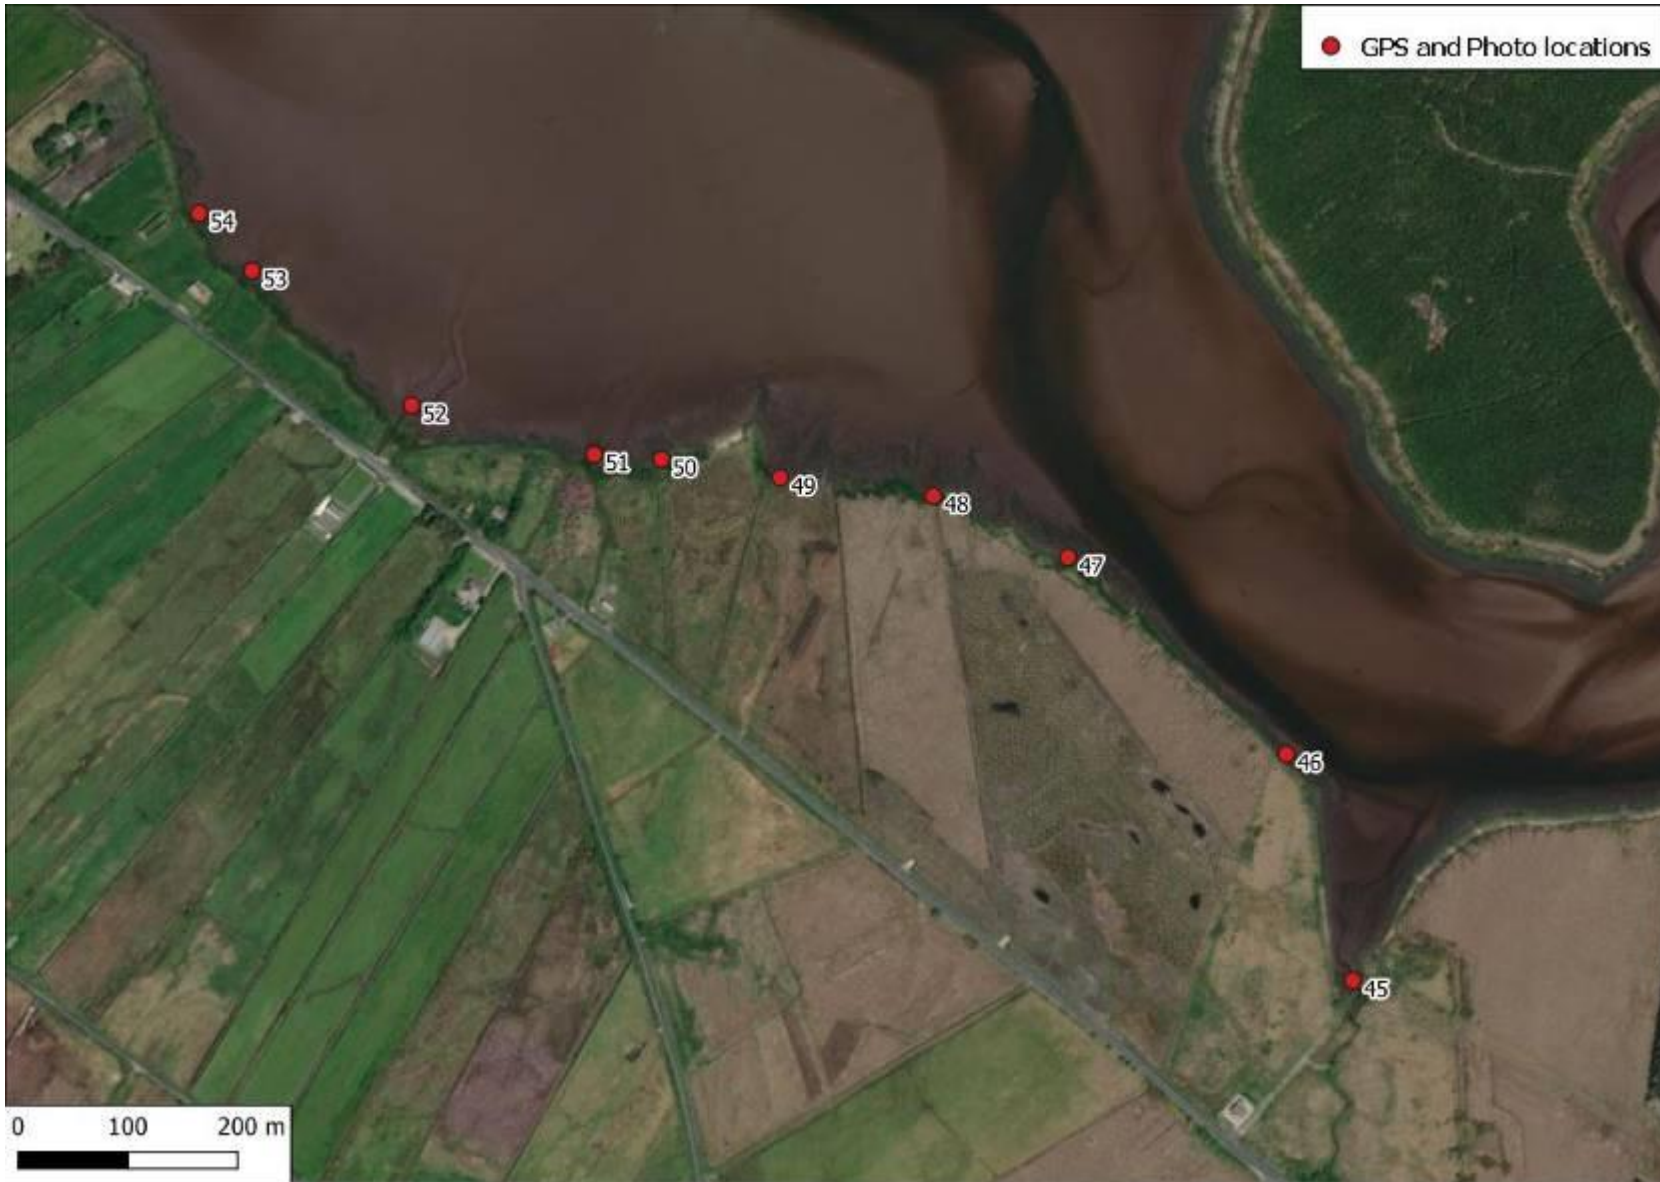
Figure 6.31: Features 45-54 (numbering cross-reference to Table 6.8) identified during the shoreline survey.

Map ID	Observation	Comments	Longitude	Latitude	Easting	Northing
52	Stream	Field drain, flowing through rough grazing land	-9.76476	54.2563	85036.8	335594.9
53	Drain	Field drain, flowing through rough grazing land	-9.76699	54.2574	84894.5	335720.9
54	Pipe	Grey pipe, not flowing. Not possible to identify origin	-9.76773	54.25787	84847.6	335774.4
55	Drain	Field drain, flowing through rough grazing land	-9.77153	54.26028	84606.7	336048.9
56	Drain	Field drain, flowing through rough grazing land	-9.77594	54.26187	84323.8	336233.1
57	Drain	Field drain, flowing through rough grazing land	-9.77723	54.26243	84241.3	336297.5
58	Drain	Field drain, flowing through rough grazing land	-9.77767	54.26248	84212.8	336303.8
59	Drain	Field drain. Low flow. Through rough grazing land.	-9.78563	54.2651	83701.6	336608.5
60	Drain	Field drain. Low flow, through rough grazing area.	-9.7876	54.26526	83573.7	336629.5
61	Stream	Stream flowing through rough grazing land. Good flow.	-9.78826	54.2656	83531.6	336668.5

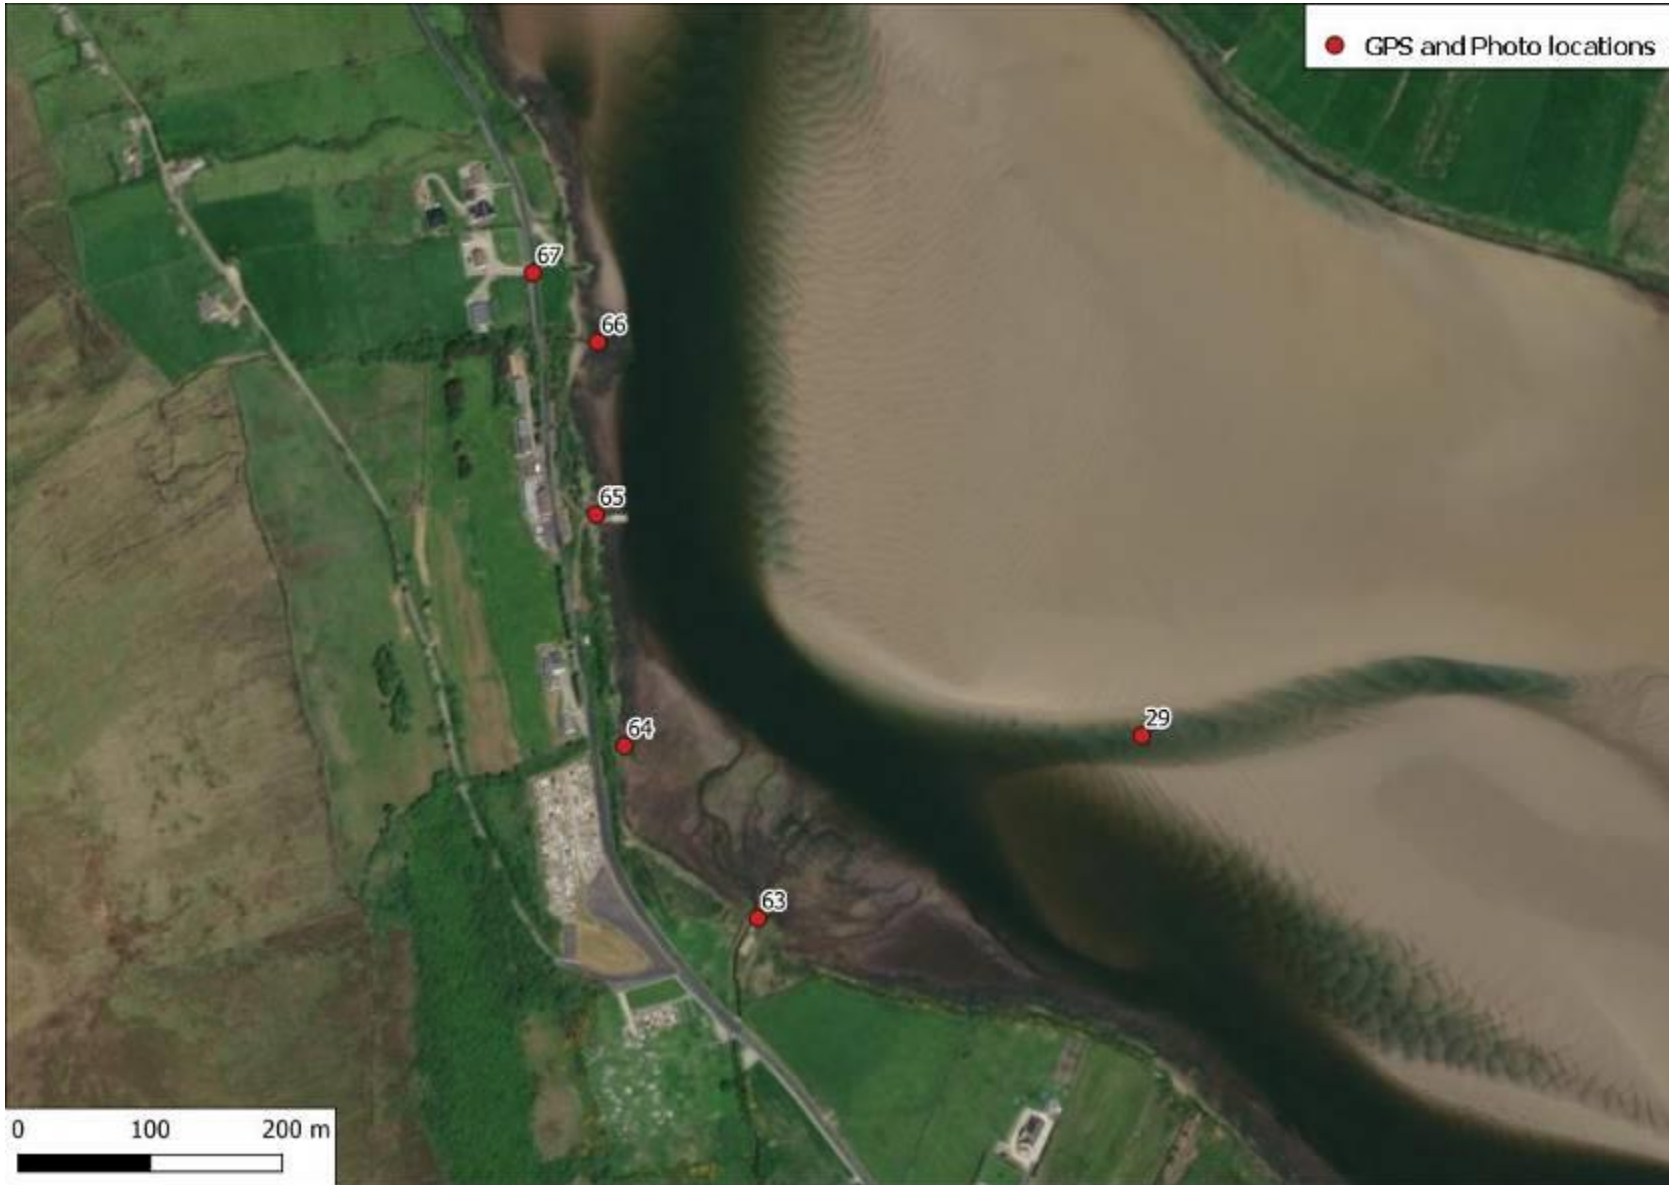
Figure 6.33: Features 63-67 & 29 (numbering cross-reference to Table 6.8) identified during the shoreline survey.

62	Stream	Stream flowing through rough grazing land. Good flow.	-9.79466	54.26622	83116.4	336748.1
63	River	Small river, good flow. Some Enteromorpha algae evident. Flows through farmland/rough grazing	-9.80222	54.26905	82631.9	337075.6
64	Drain	Flowing off high bank beside road. Likely field rain related.	-9.80377	54.27022	82534.3	337208.4
65	Pier	Small pier, no boats or berths noted.	-9.8041	54.27179	82517.3	337383.7
66	Stream	Stream flowing of steep hill, sheep on pasture above.	-9.80408	54.27296	82521.9	337513.8
67	Drain	Field drain from hill above	-9.80483	54.27343	82474.4	337567.4
68	Sheep	Approx 15 on grassland	-9.813355	54.2834	81947.6	338691.3

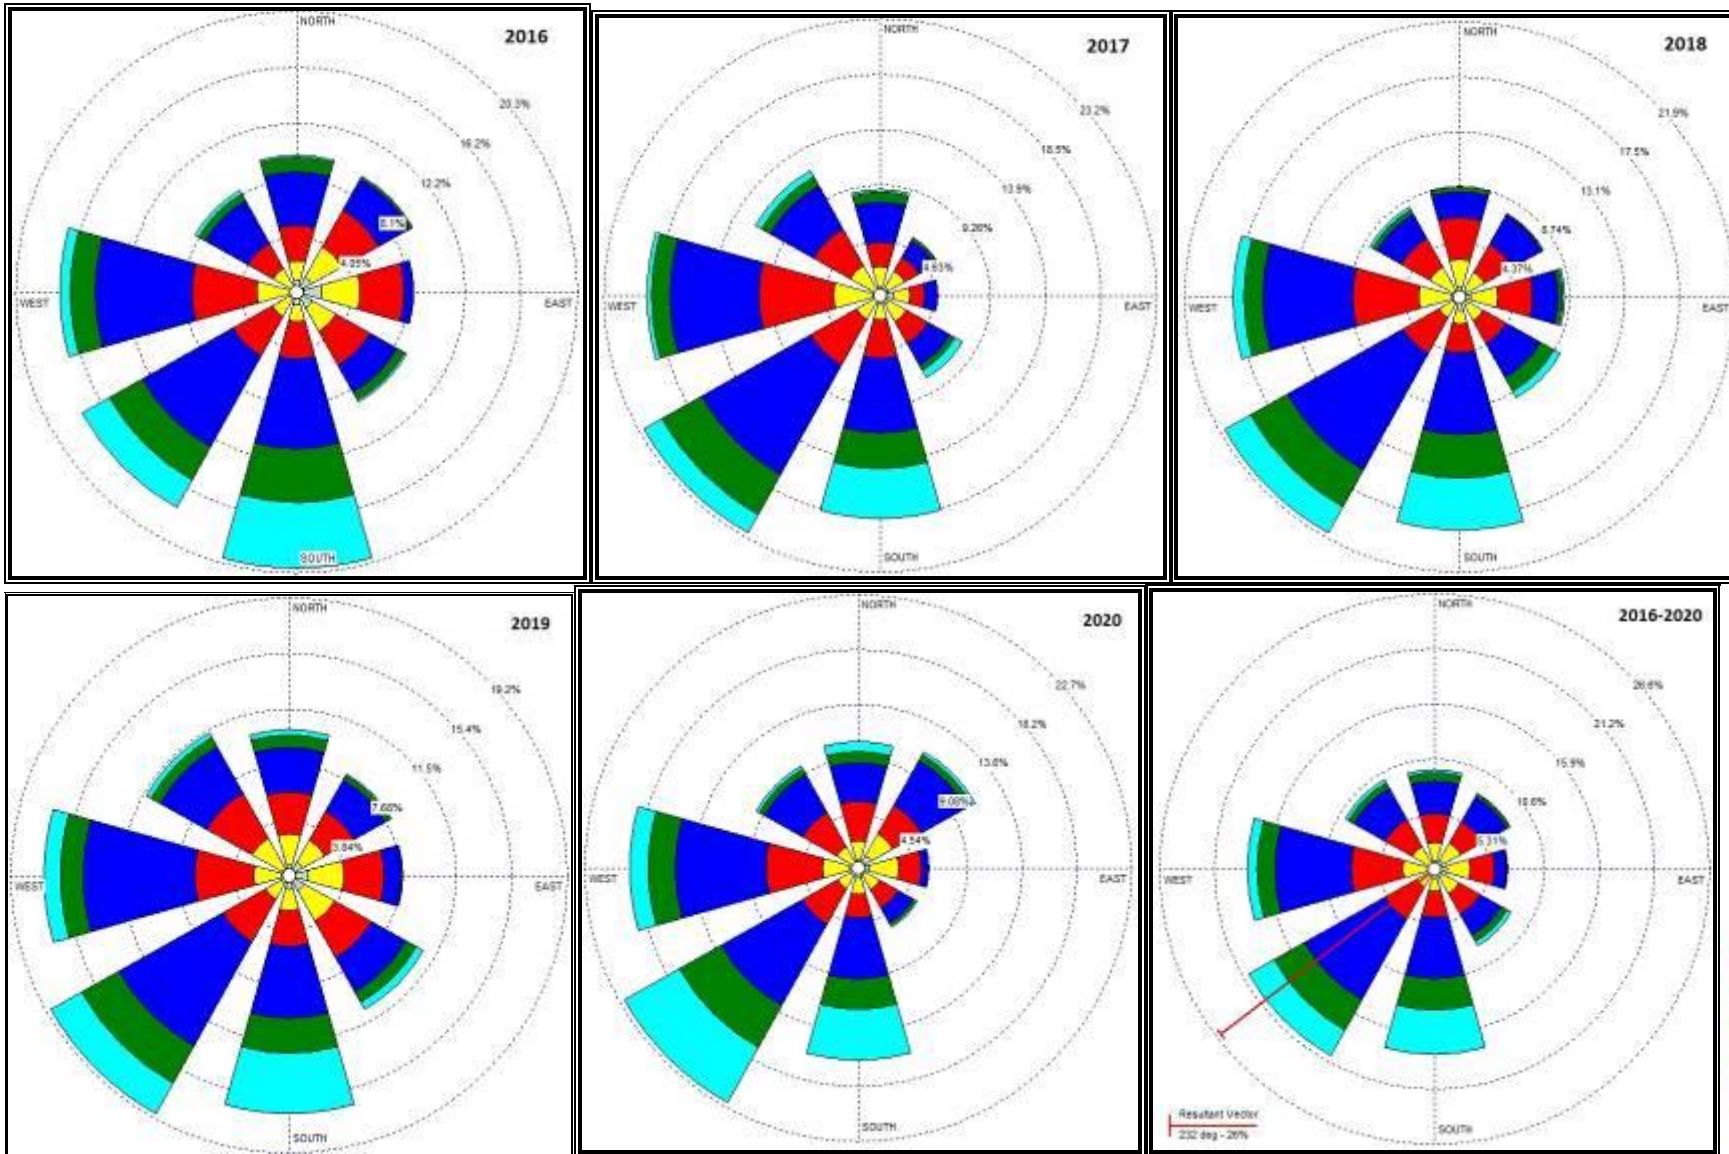
Figure 7.4: Wind roses for Belmullet from 2016 to 2020 (Source: Met Eireann, 2021a).

Wind conditions affect the hydrodynamic conditions in Sruwaddacon Bay by generating wind-induced currents and waves. Of these phenomena, wind-induced waves are an important factor in the process of sediment resuspension and transport. Wind waves are produced by the local prevailing wind. They travel in the direction of the prevailing wind, *i.e.* a southwesterly wind will produce northeasterly moving waves.
