**Sanitary Survey Report and Sampling Plan
for Coulagh Bay, Co. Cork**

AQUAFACT - APEM Group

The Sea Fisheries Protection Authority

November 2024

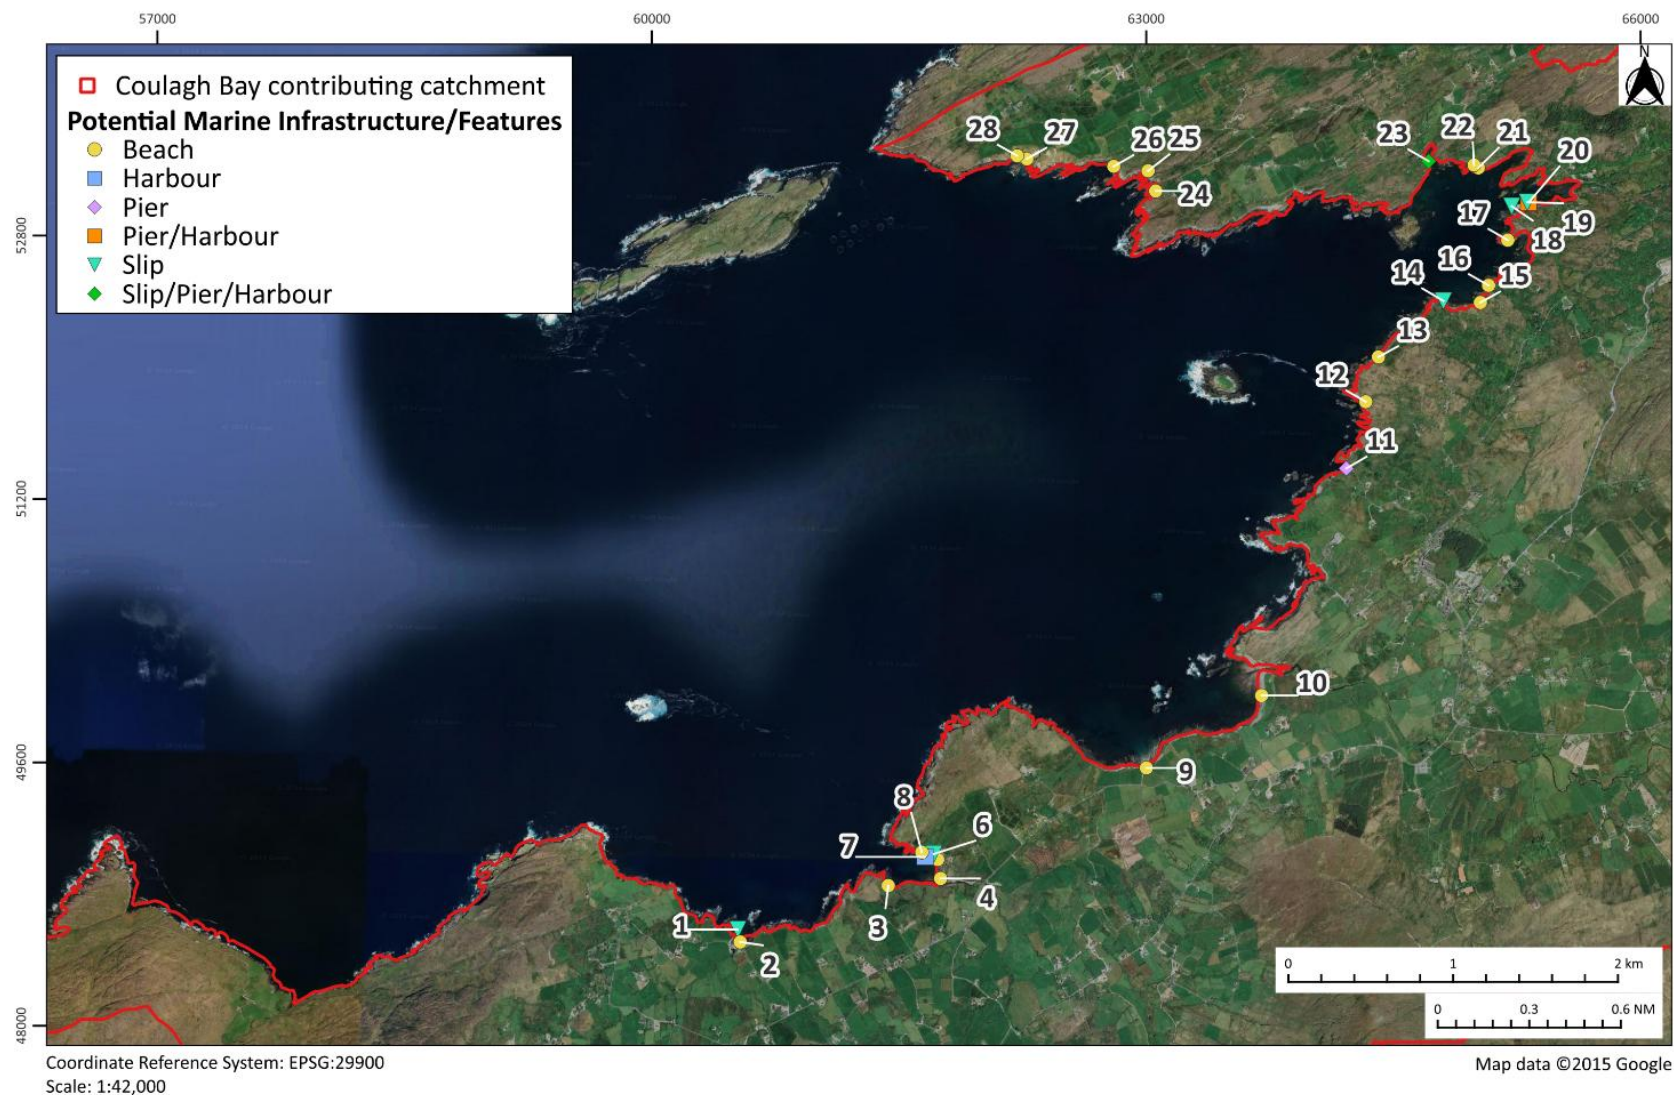
Figure 7-16: Potential beaches, ports, piers, marinas, and slips identified during the desktop review that were to be confirmed by the shoreline survey. Map IDs cross-referenced to Table 7-9.

Figure 7-16 shows all potential boat facilities and activities, namely slipways, piers, ports, and beaches within Coulagh Bay contributing catchment; **Table 7-9** details these facilities. There were 26 boat facilities/activities noted from the desktop survey to be confirmed/discounted by the shoreline survey. A tourist vessel operates out of Ballycrovane Pier seasonally (*per comms.* Beara Boat Tours).

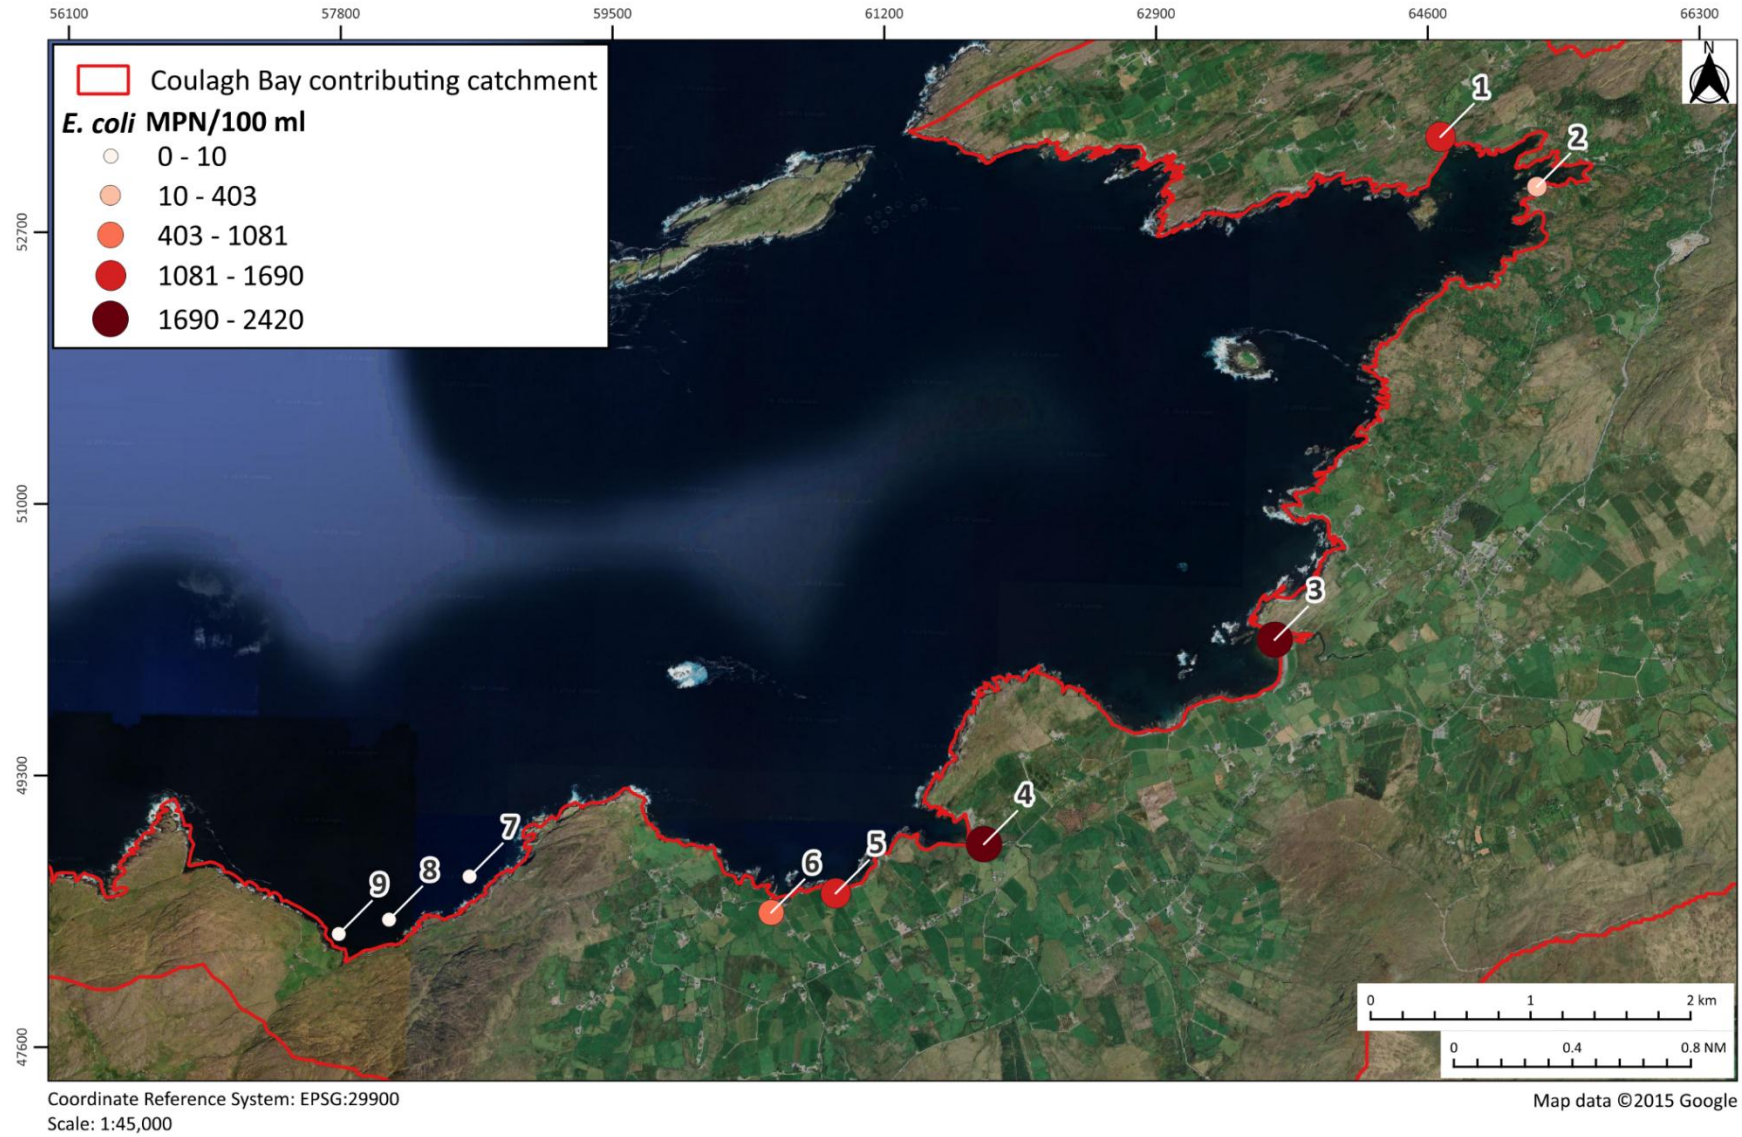
Figure 9-1: Location and magnitude of *E. coli* (MPN/100 ml) results from the water samples taken during the shoreline survey (numbering cross-referenced to Table 9-2).

One RMP is recommended for shellfish production within the Coulagh Bay BMPA. RMP 1 has been placed on the shoreward side of site T05-523A in order to be most effective at capturing *E. coli* levels, as the majority of potential *E. coli* sources come from the land and shore (**Figure 6-1, Table 6-2**). Within the BMPA, the highest density of discharges occurs to the south and southeast of T05-523A. From the water samples taken during the shoreline survey, the two samples with the highest *E. coli* levels (MPN/100 ml) are located close to the shellfish site too (stations 4 and 5, **Figure 9-1**).
